# 53 Nicol Street

# 206 Fifth Street

# 5030 Lost Lake Road

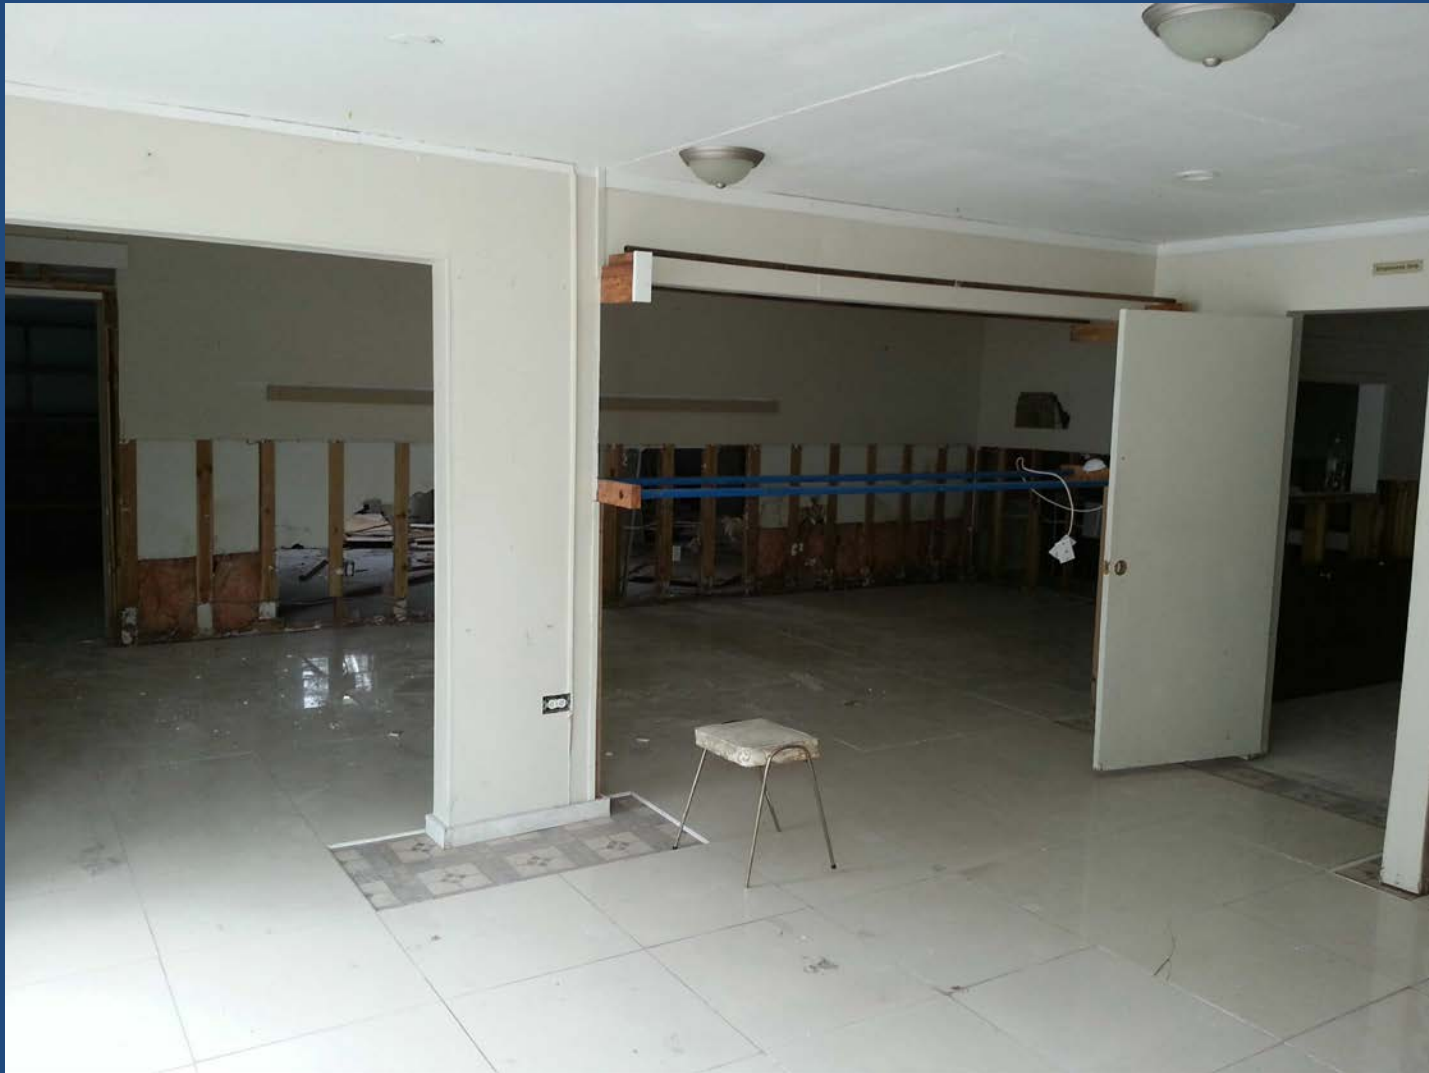
2015 image of lower floor commercial rental unit (CRU).

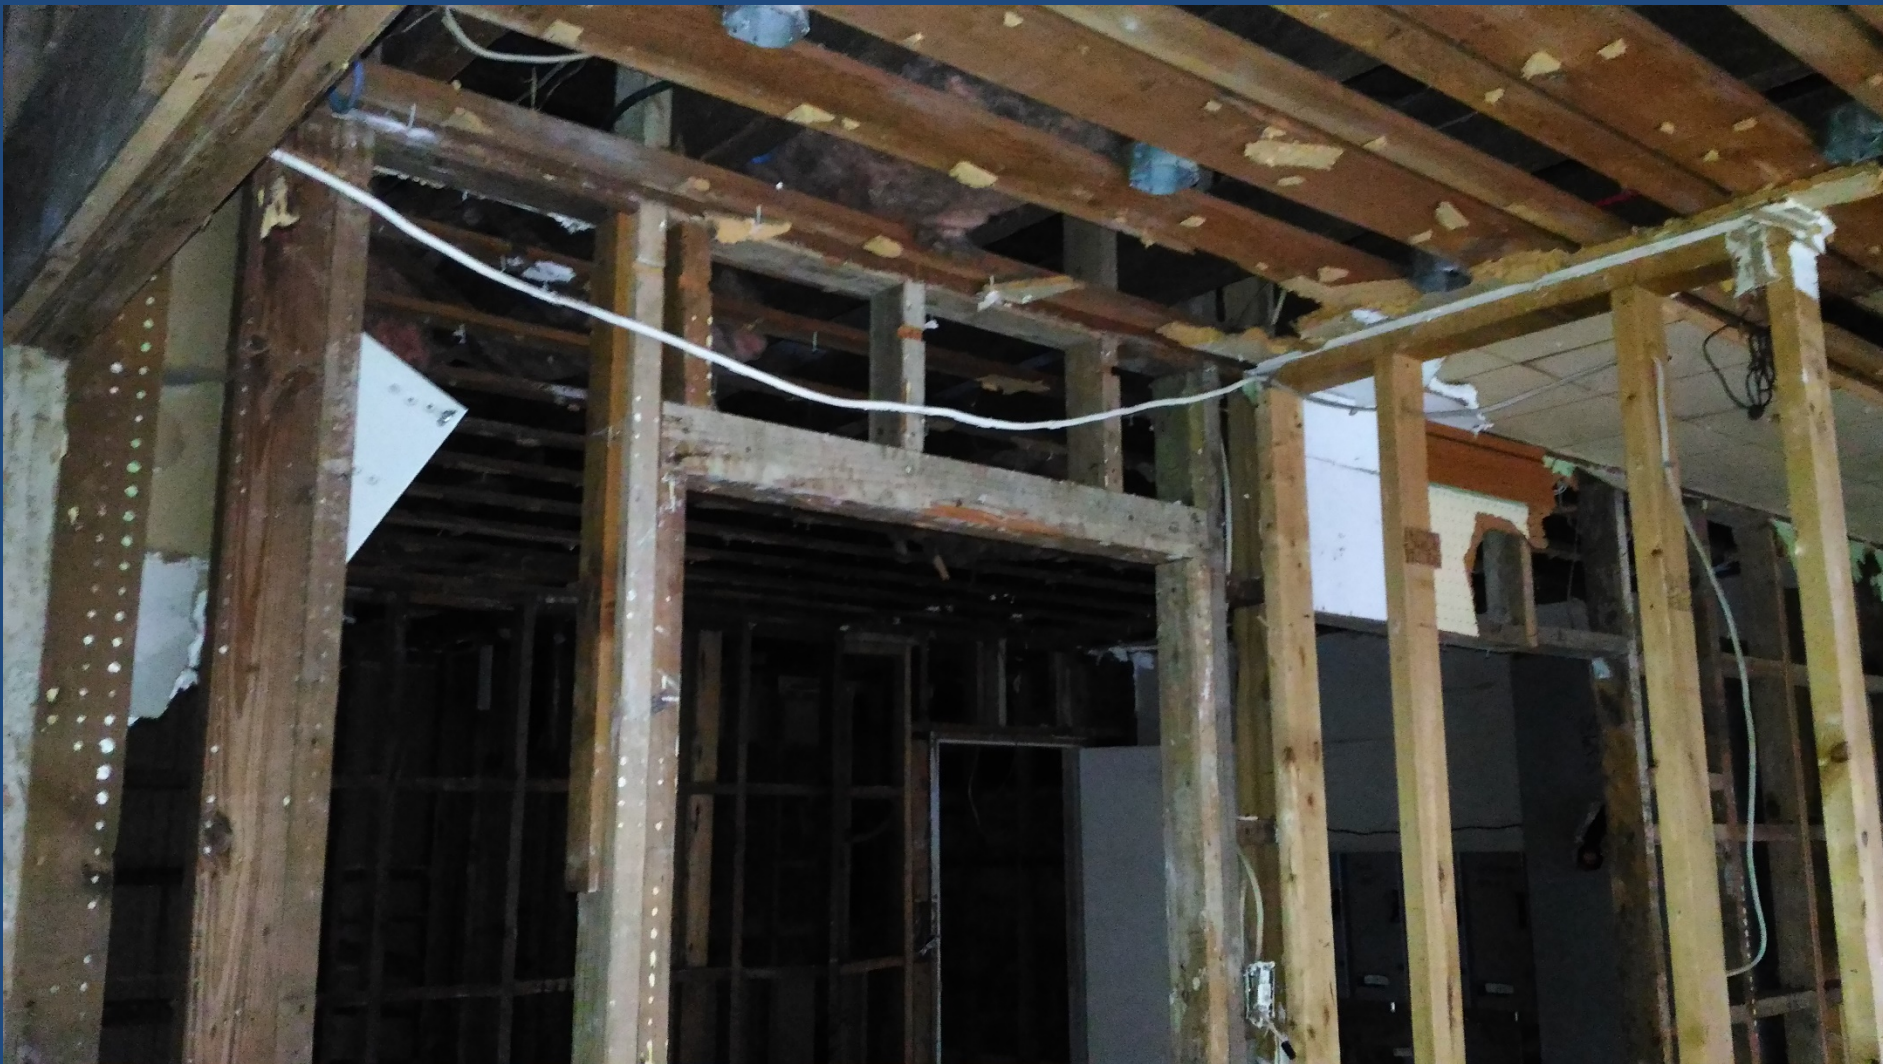
# 53 Nicol Street

2018 image of lower floor CRU.

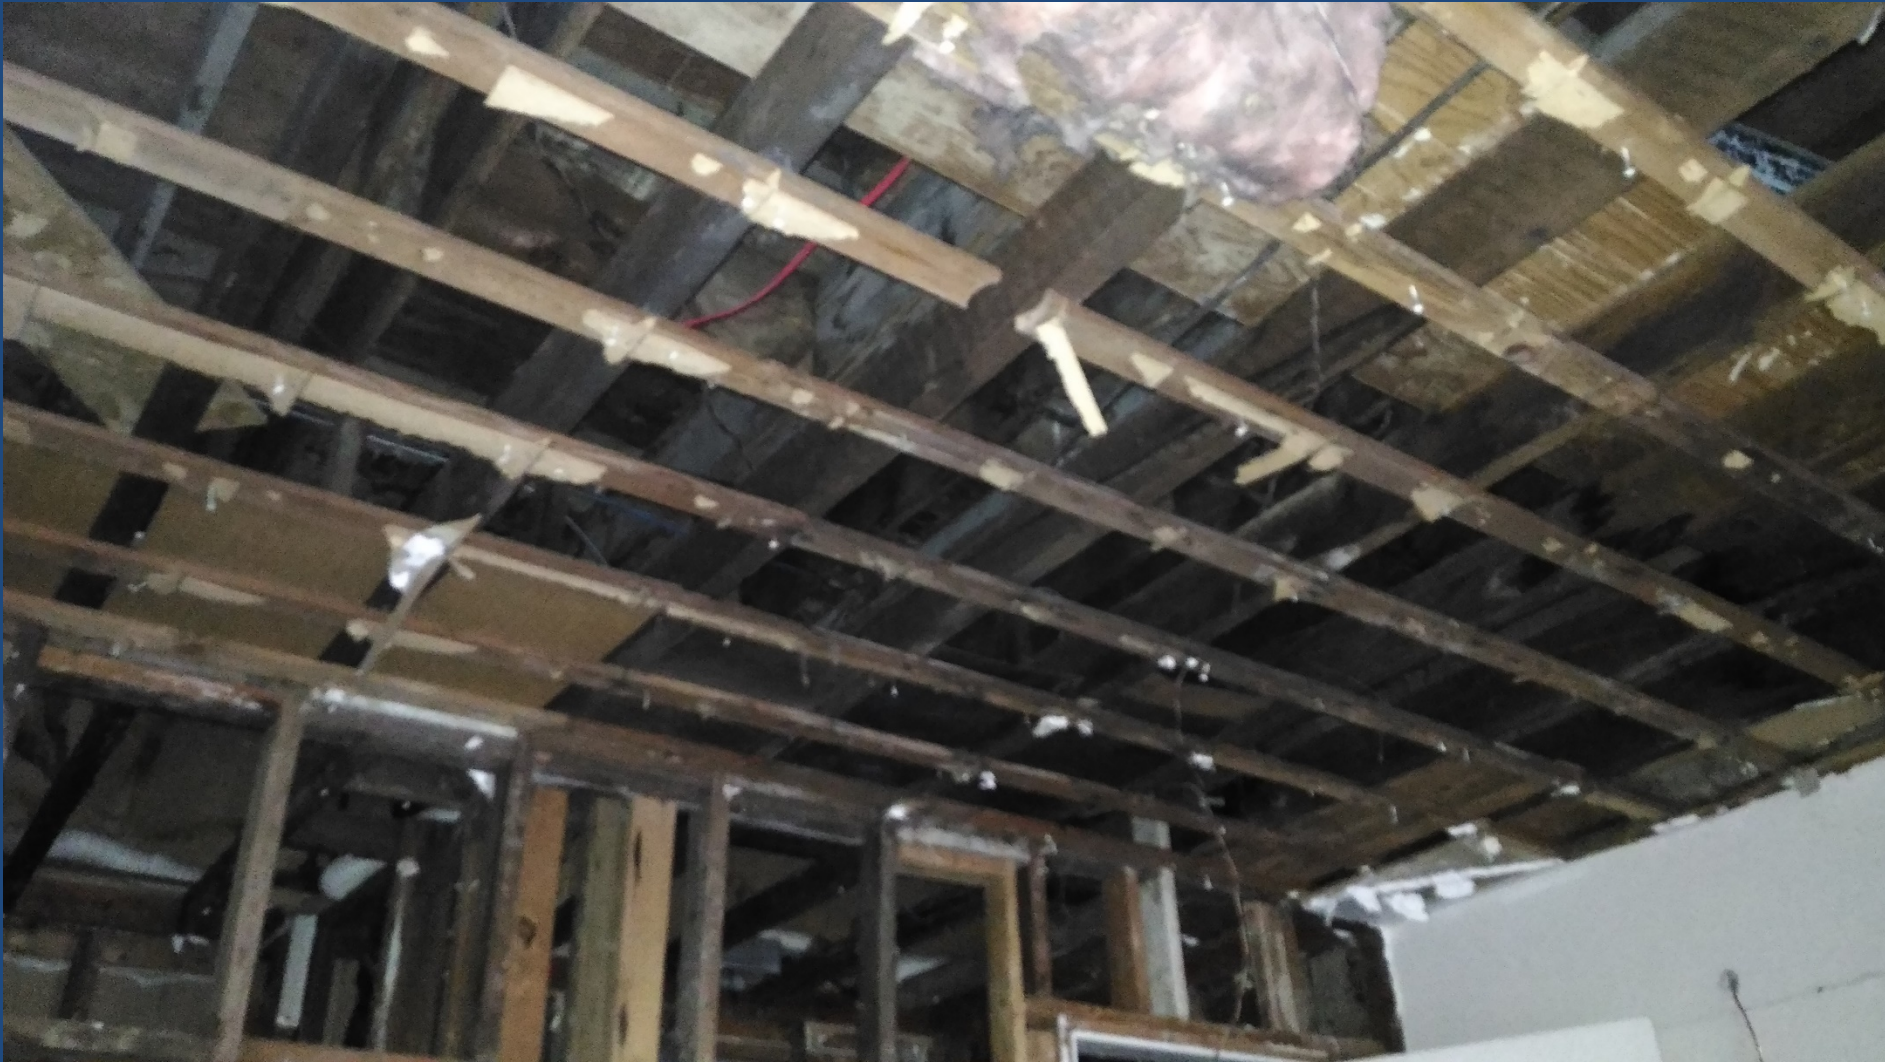
## 53 Nicol Street

The fire-resistant ceiling materials have been removed from the lower floor CRU. There is now no fire separation protection between the commercial unit below and the residential units above. The lower floor is being used as storage.

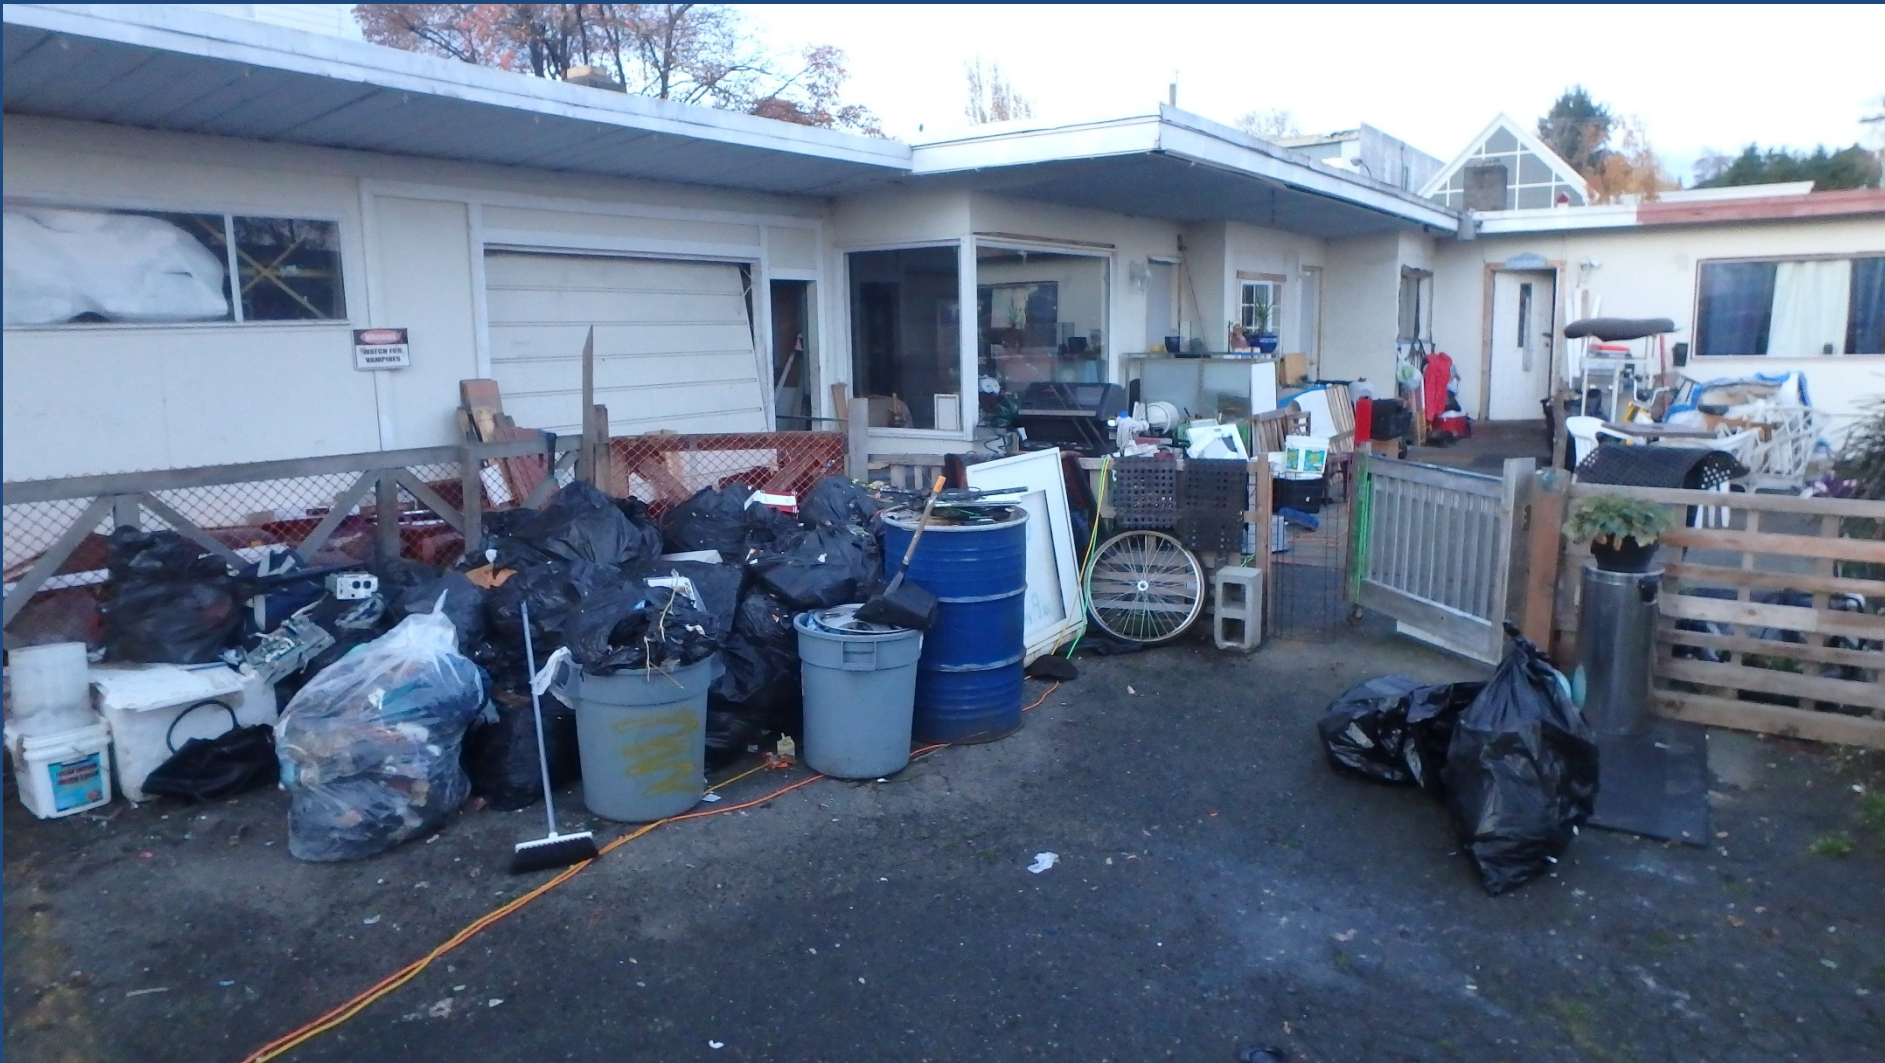
# 53 Nicol Street

2018 image of residential units on upper level.

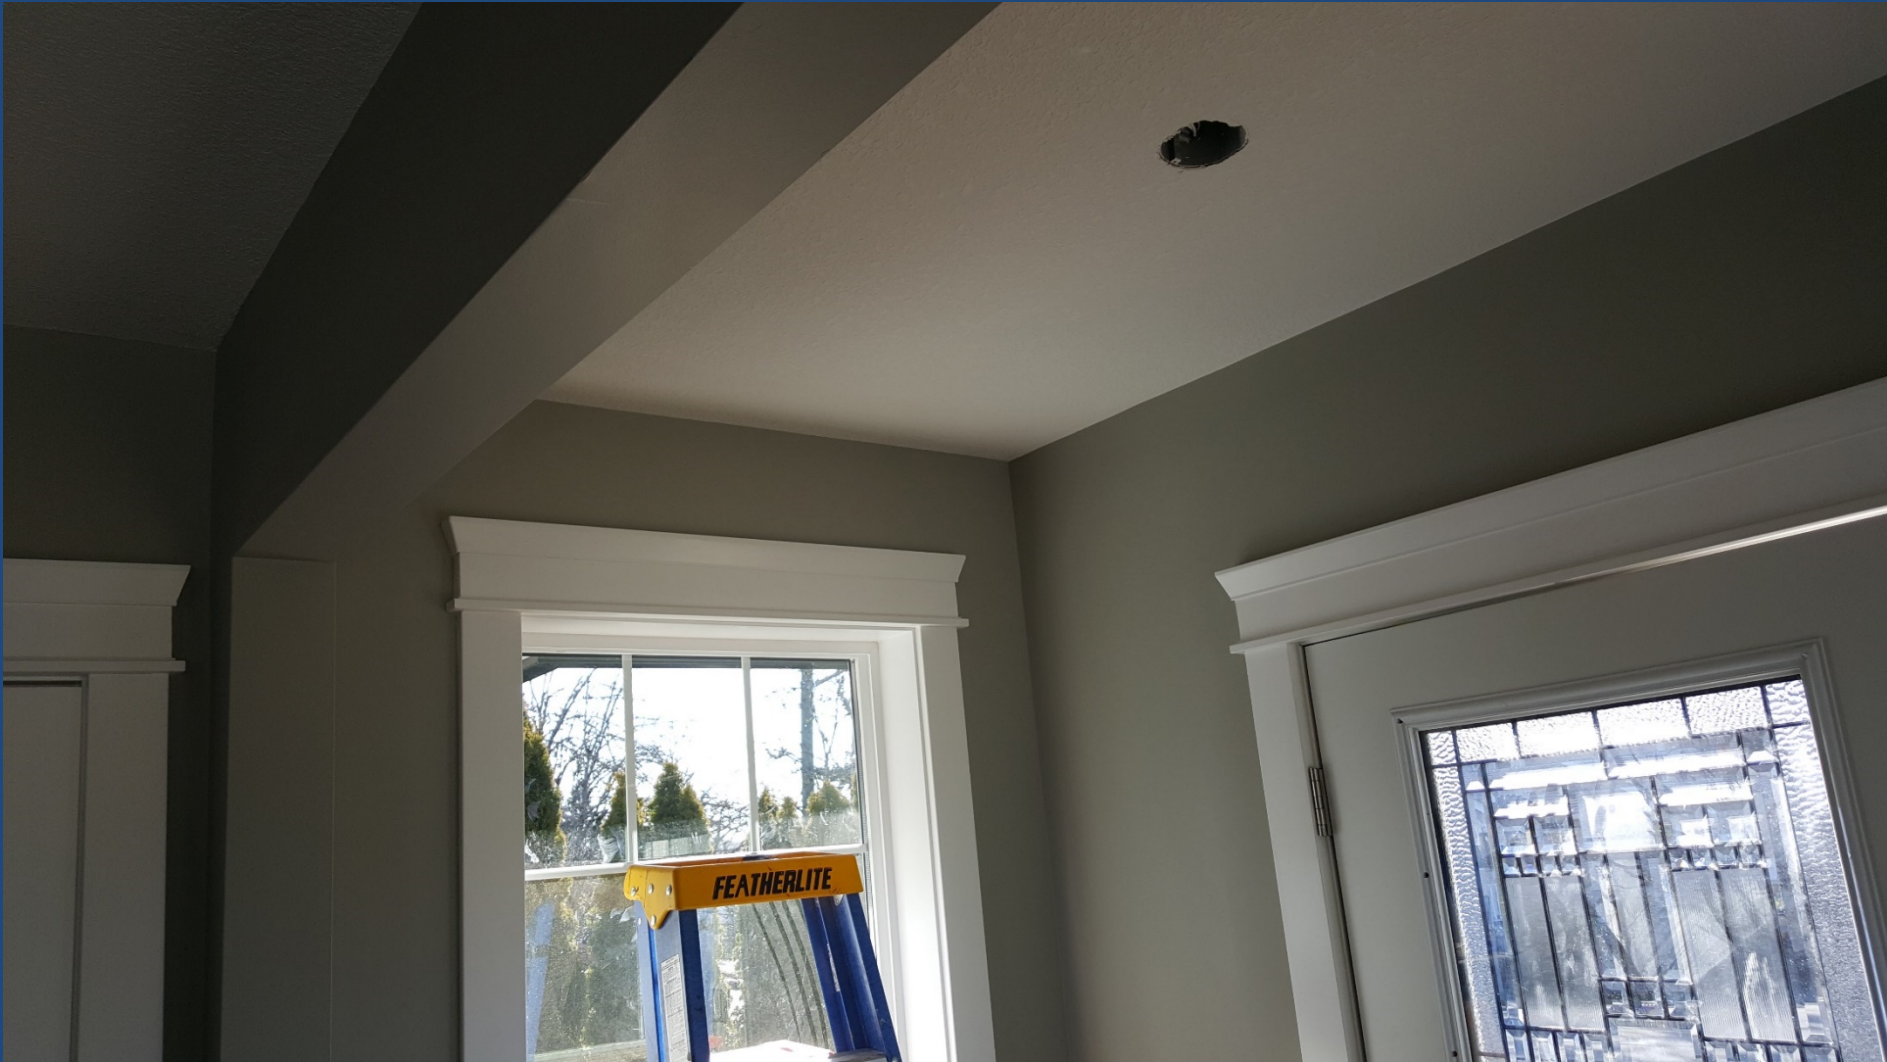
New front entry porch finished without inspections.

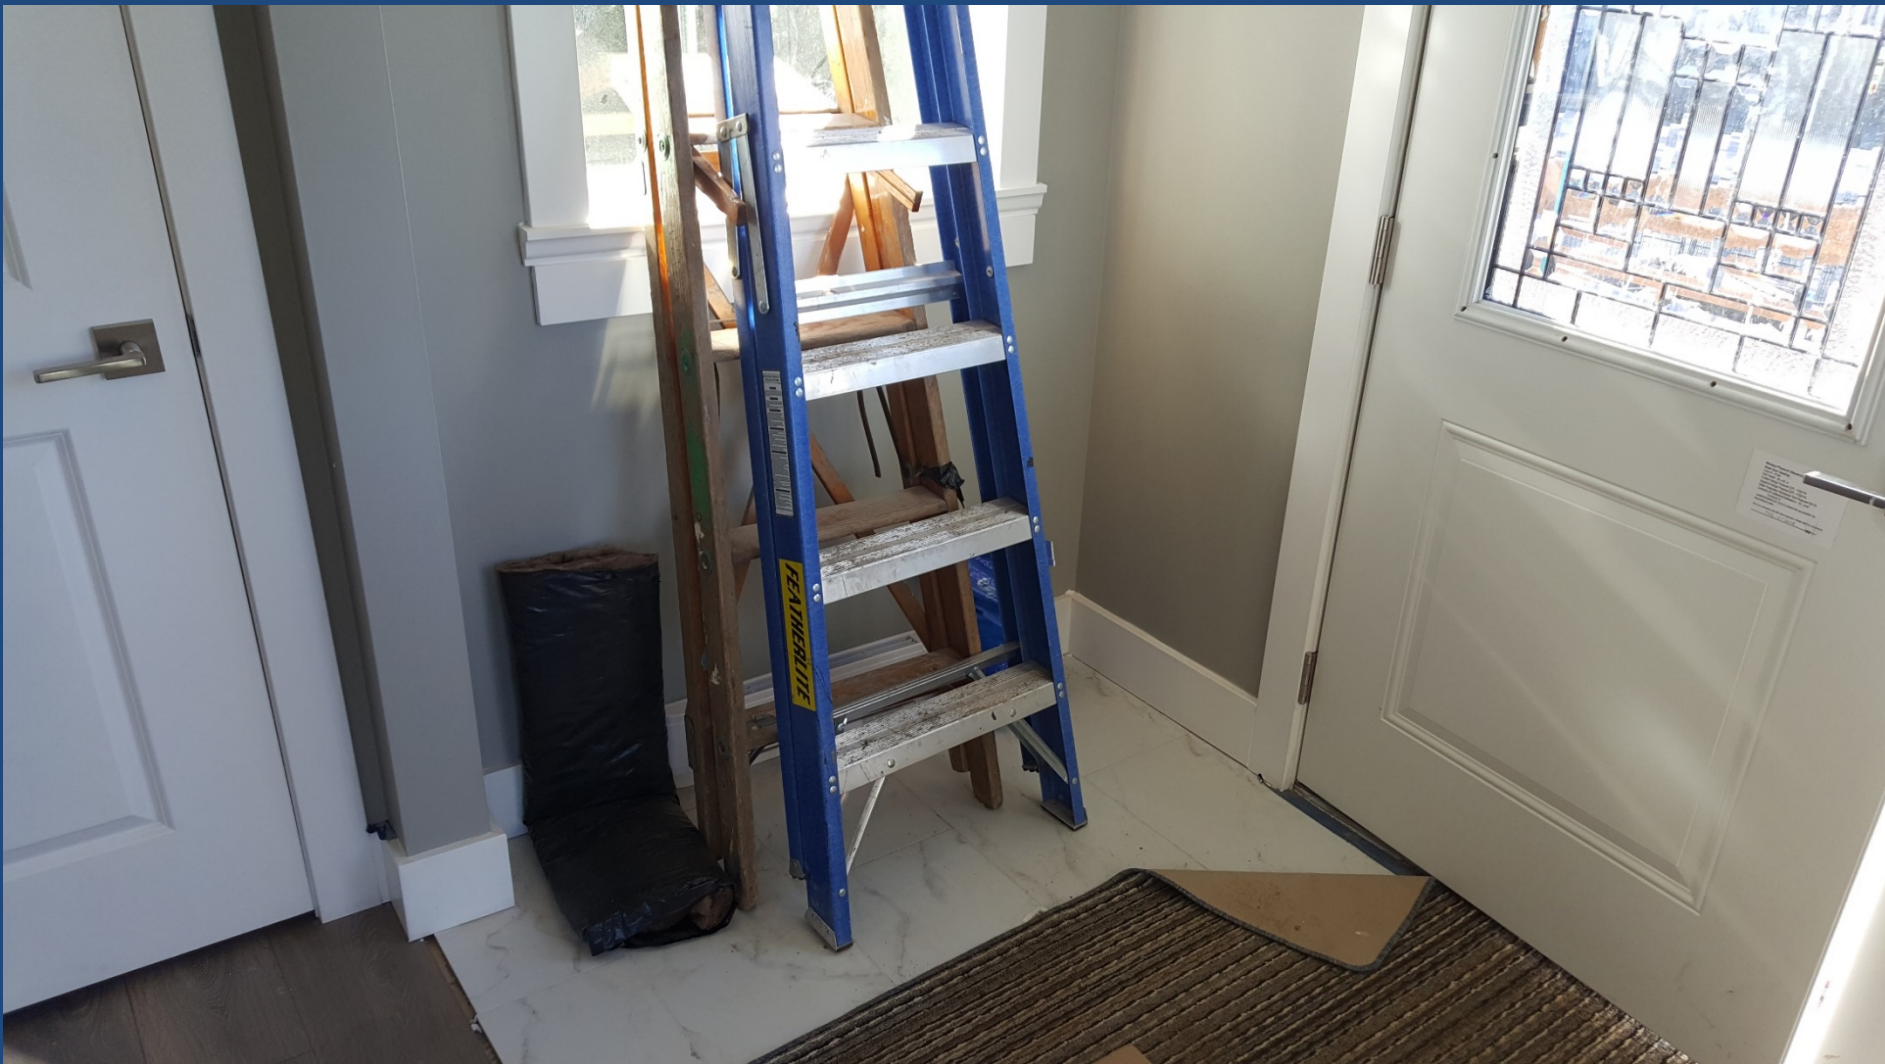
# 206 Fifth Street

New front porch.

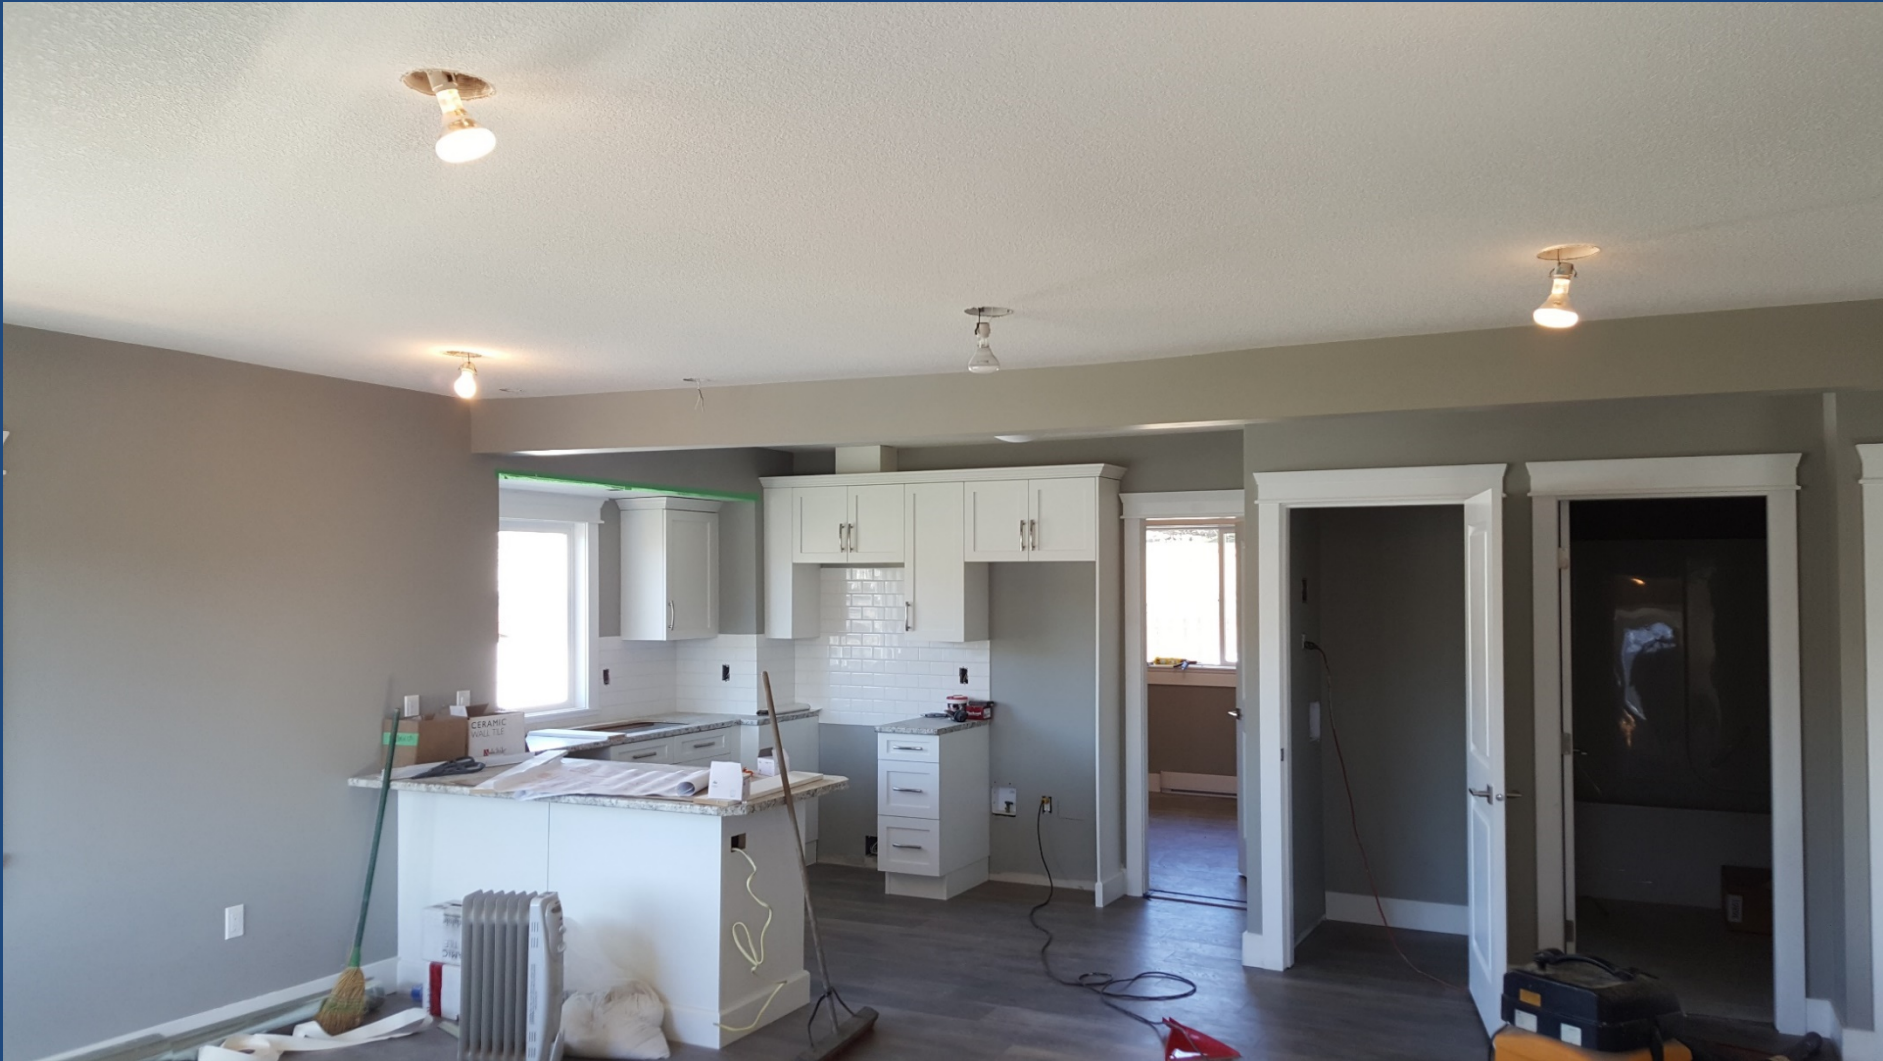
# 206 Fifth Street

Main floor living space completed without inspection.

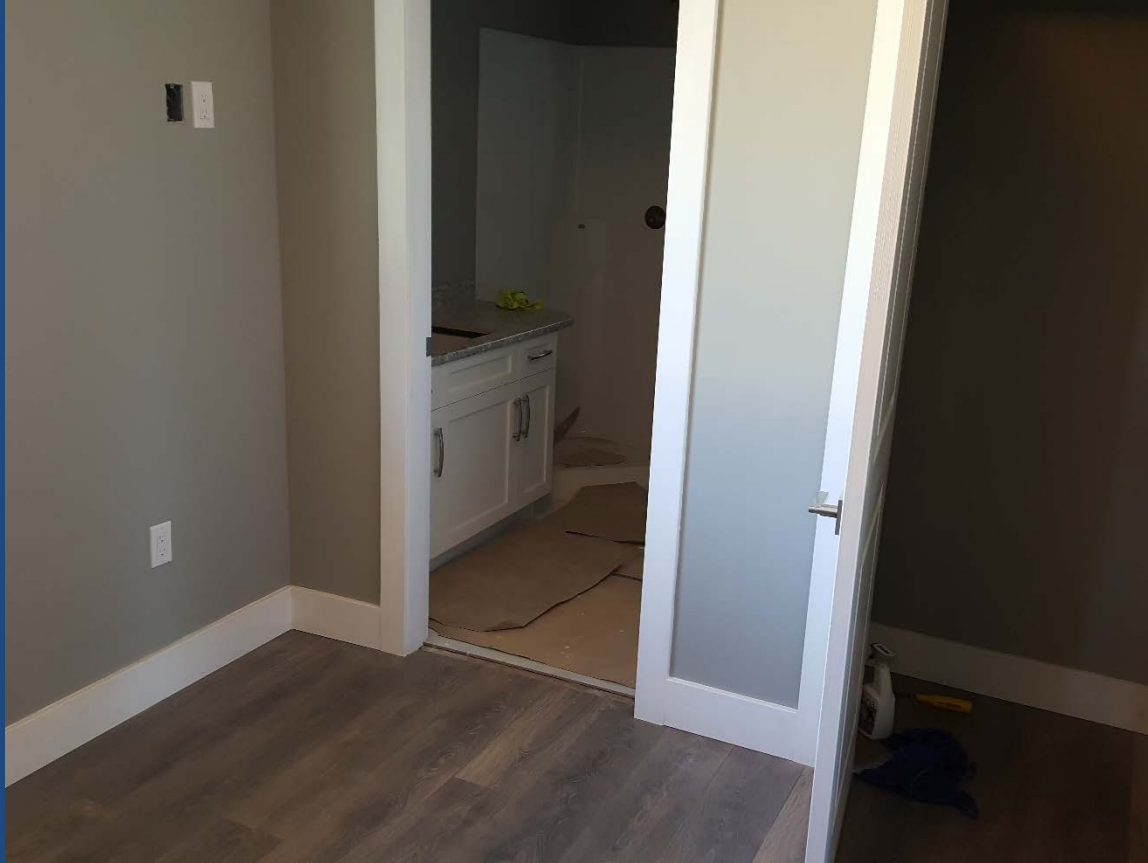
**Ensuite addition inspections not completed.**

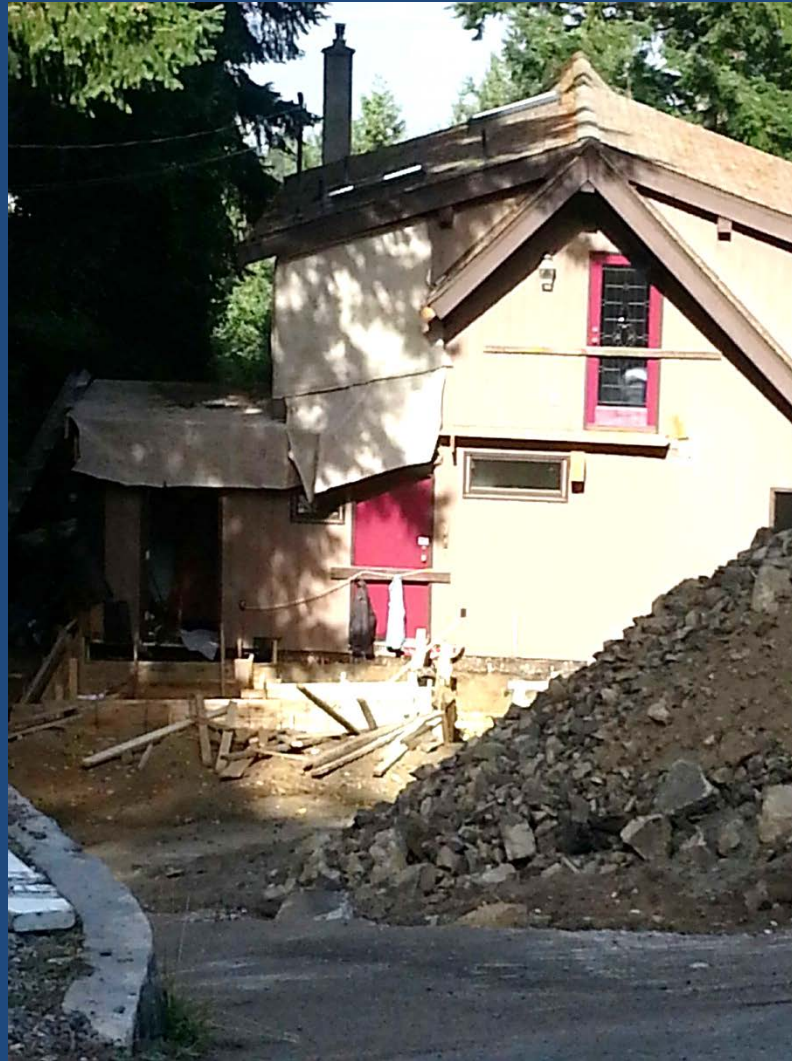
Site photo prior to the issuance of the building permit.

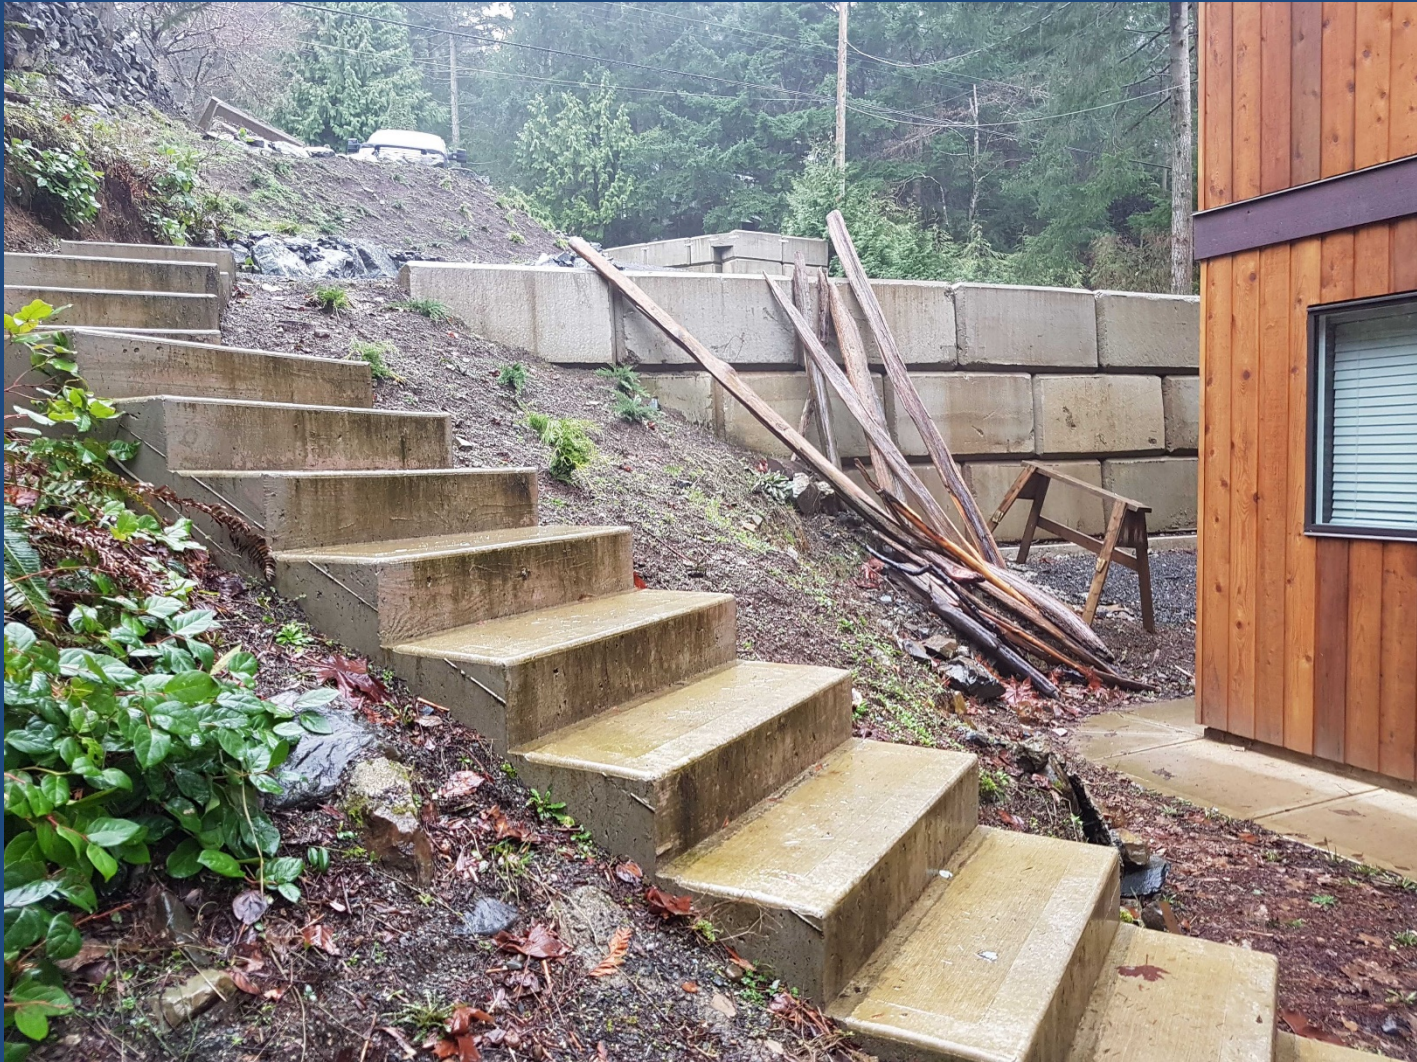
# 5030 Lost Lake Road

Access stairs from parking level. Handrail required on stair, and guard on retaining wall in background.

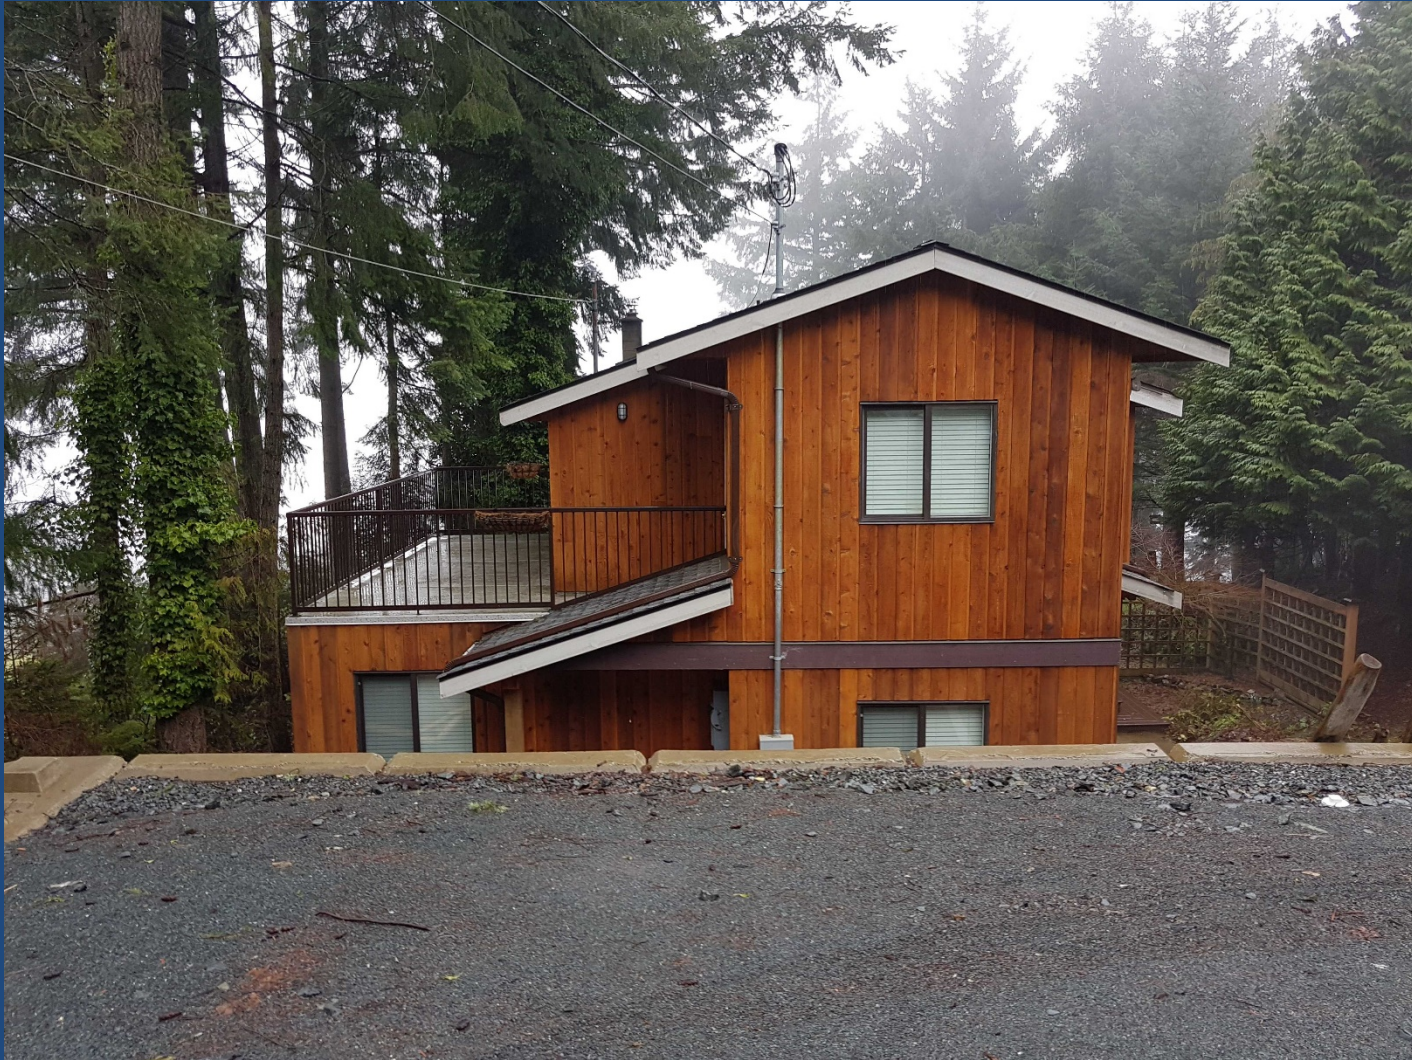
# 5030 Lost Lake Road

Parking area with no guard rail.

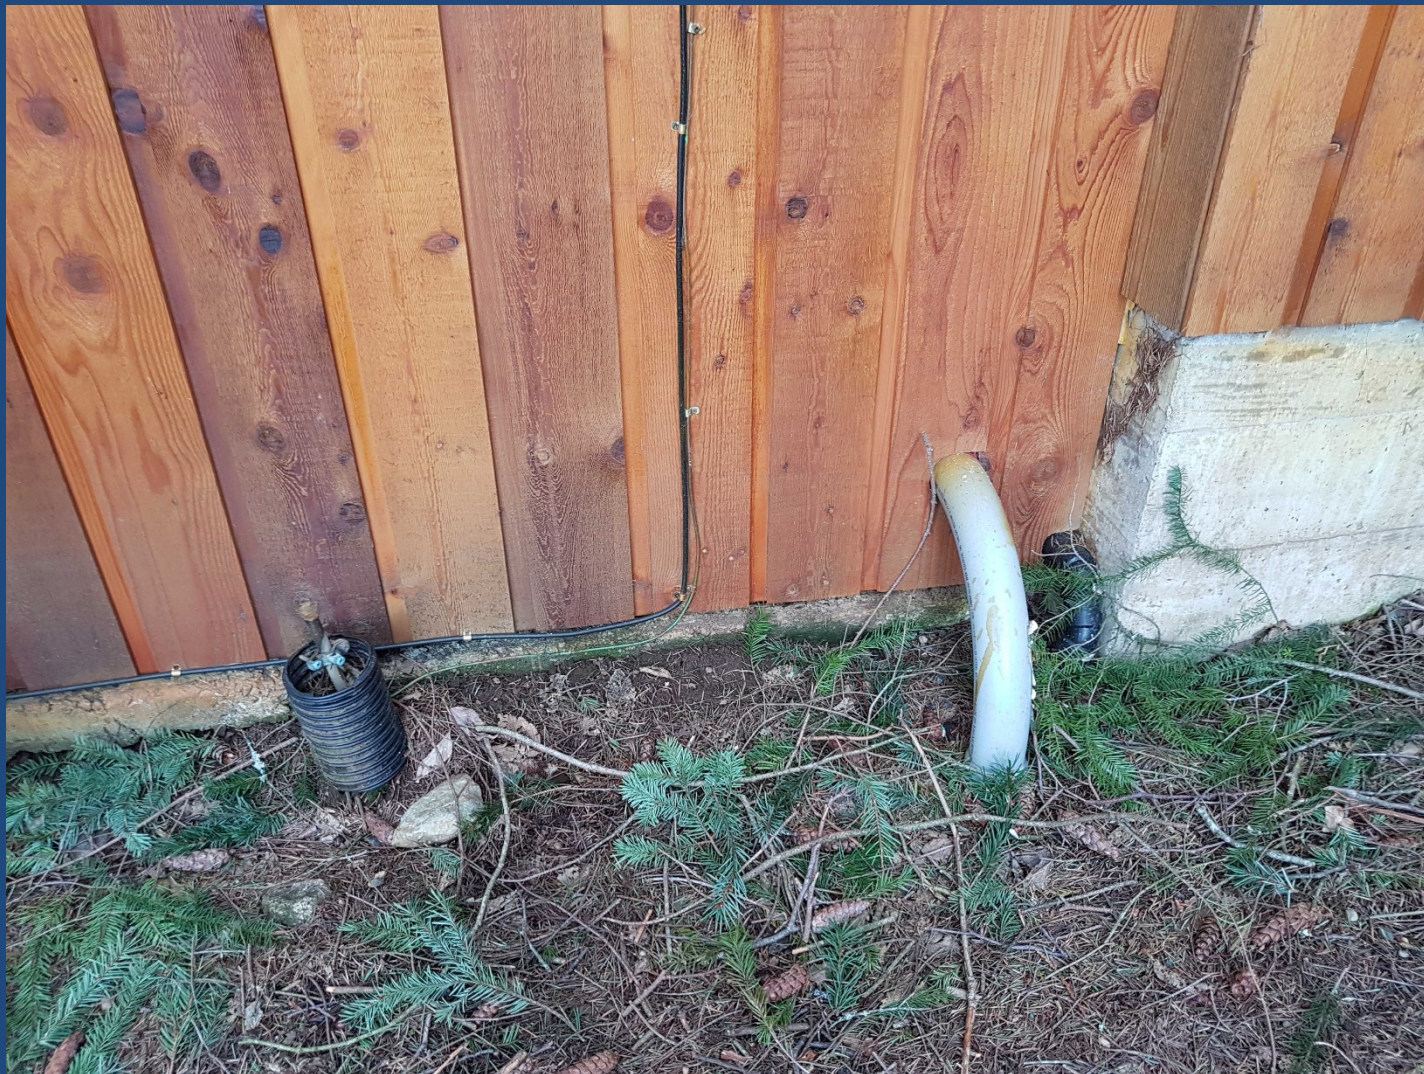
# 5030 Lost Lake Road

Plumbing pipe penetrations through exterior wall  
to be confirmed and protected.

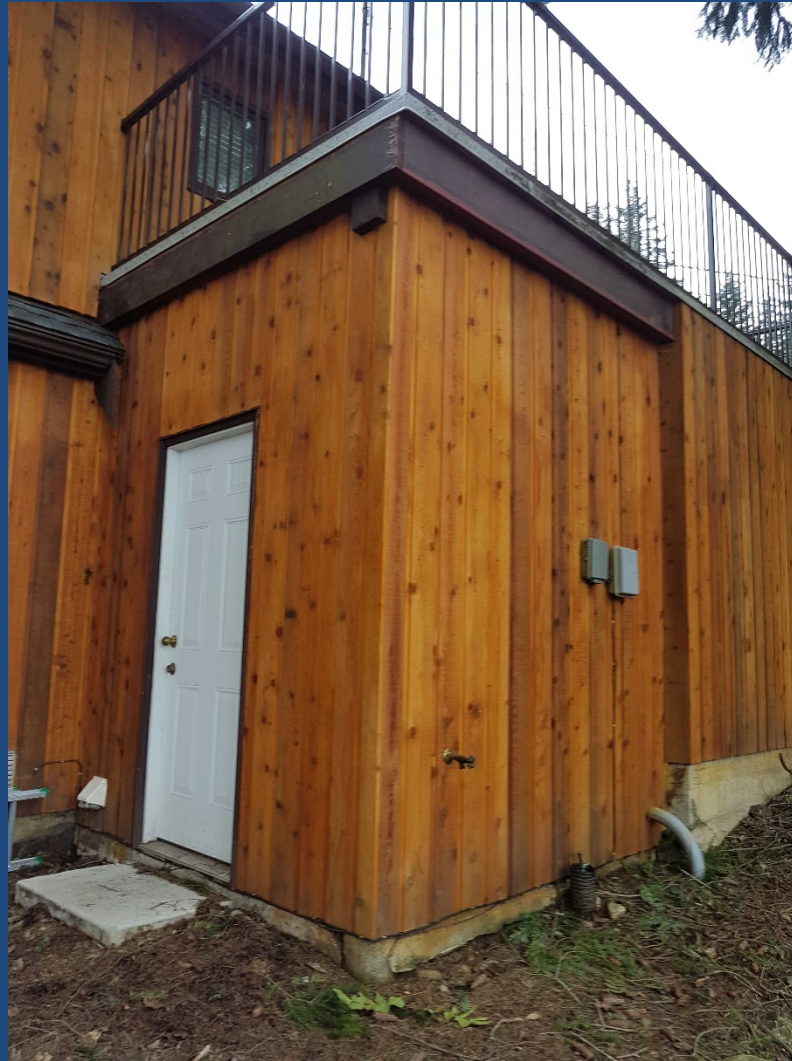
# 5030 Lost Lake Road

Layout changes to exterior elevations of storage room.

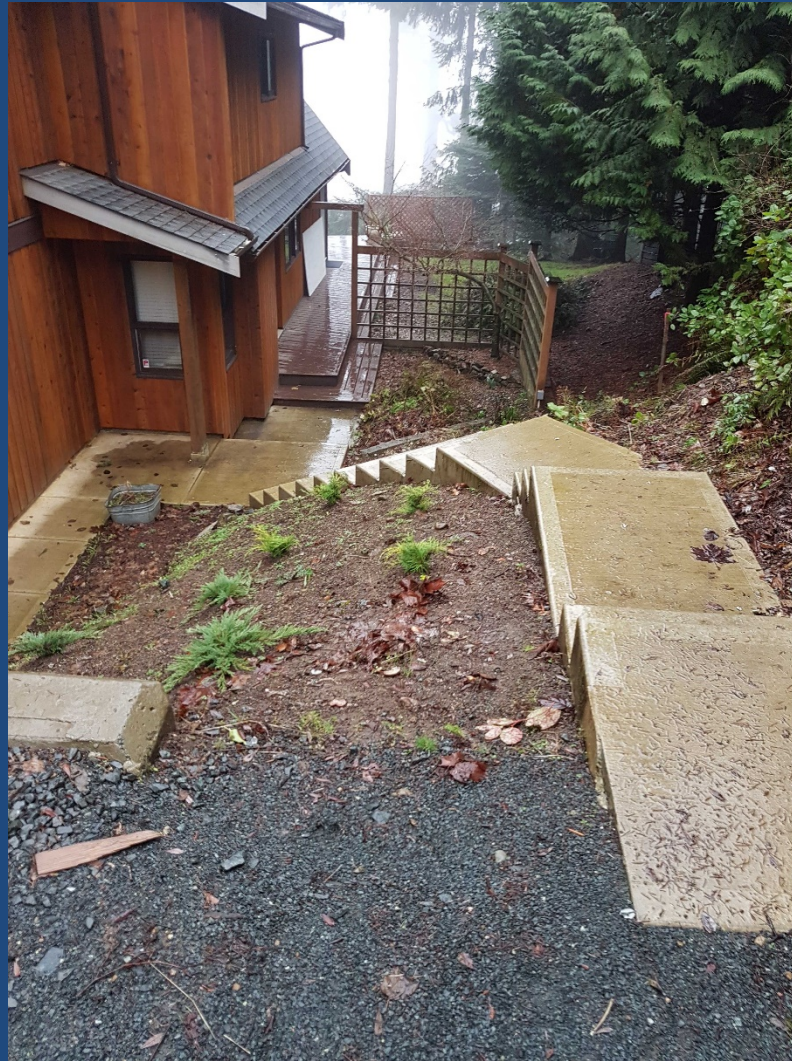
# 5030 Lost Lake Road

View from elevated parking area, main access to dwelling unit.
