January 25, 2019

0017-359

**Re: City Dockhead at Gallows Point Follow-Up Condition Assessment - DRAFT**

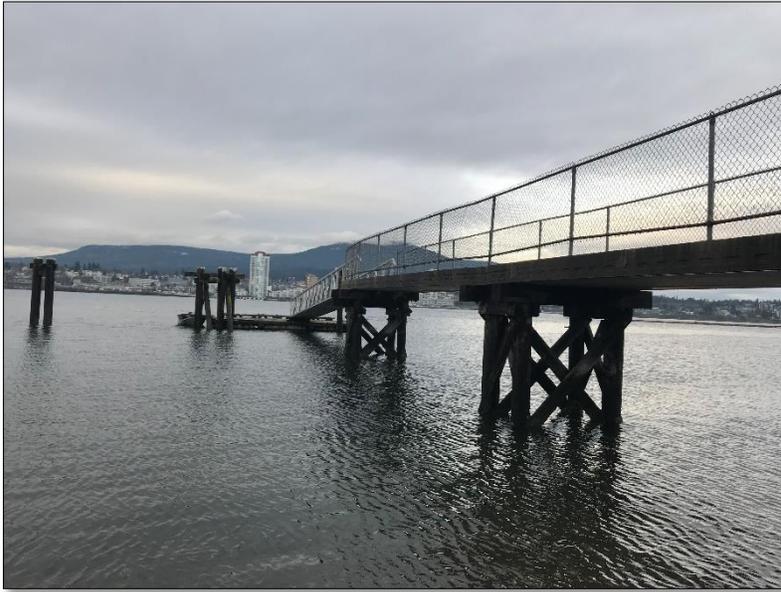
Photograph 1: City Dockhead at Gallows Point, note: general arrangement

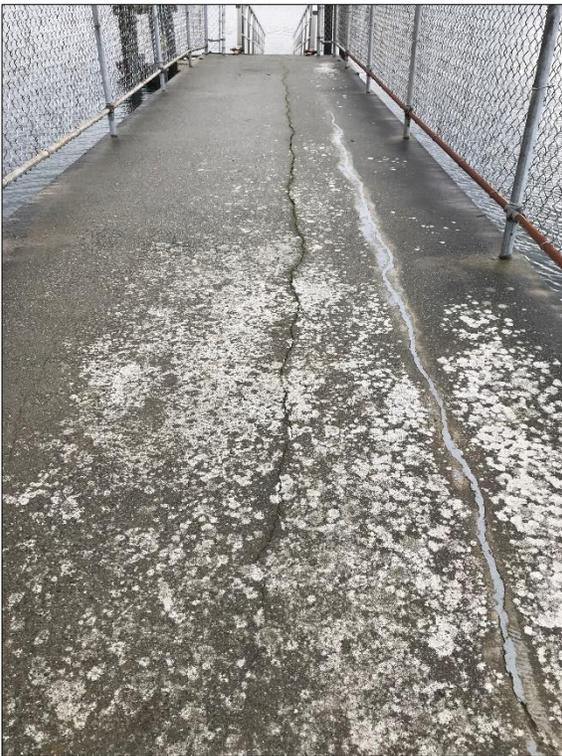
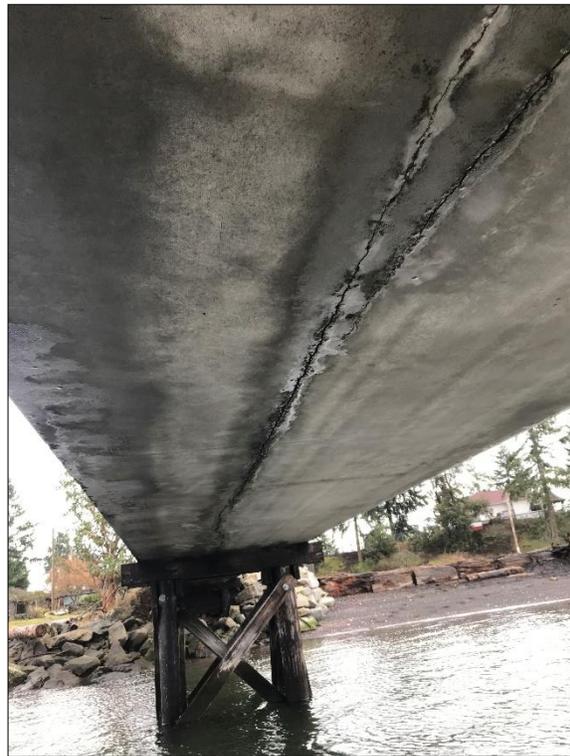
- At the seaward end of the chain-link fence there is a gap between the end of the fence and the gangway handrail. The gap width exceeds 102mm, and does not meet OH&S requirements for guards.
- The pre-cast hollow core panels have long longitudinal cracks which penetrate the section. There is evidence of water seepage through the cracks.
- The timber cross bracing is significantly decayed at the cut ends. This deterioration penetrates the lower connection in various locations.
- Bearing pile 4B has a large hole at the mudline with 80% cross sectional loss (CSL).

Photograph 2: Pre-cast hollow core deck panels, note: longitudinal crack penetrating the section, water seepage

The longitudinal cracks penetrating the pre-cast hollow core panels are recommended to have crack monitoring assemblies installed along the underside of the panel. The crack size is recommended to be monitored at each routine facility inspection. The assembly is a simple system which Herold Engineering is pleased to install at the facility should the City require.

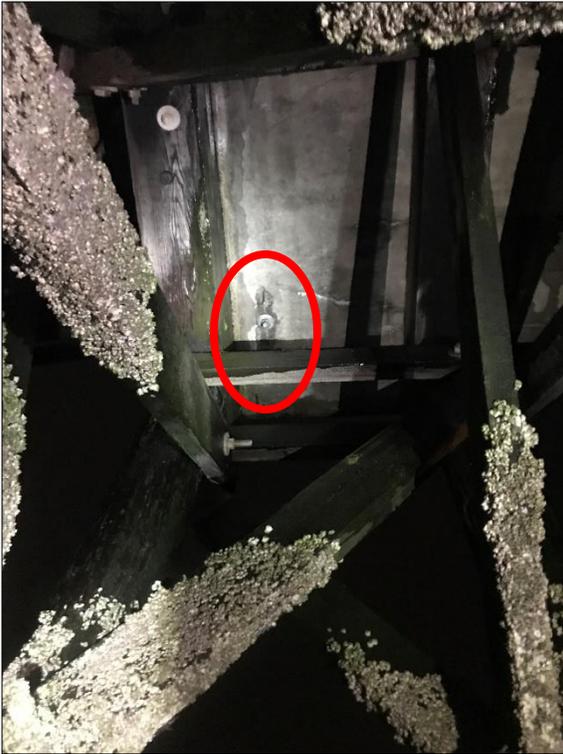
- The pre-cast concrete deck panel along the approach has moderate amounts of spalling at the gangway thru-bolt connection. Reinforcing steel is visible and appears corroded.
- Bearing pile 2A was identified as having 75-80% CSL at an abandoned lower bolt hole located within the intertidal zone.

Photograph 3: Pre-cast hollow core deck panels, note: spalling at thru-bolt location

The spall on the underside of the pre-cast panel at the gangway connection is recommended to be patched.

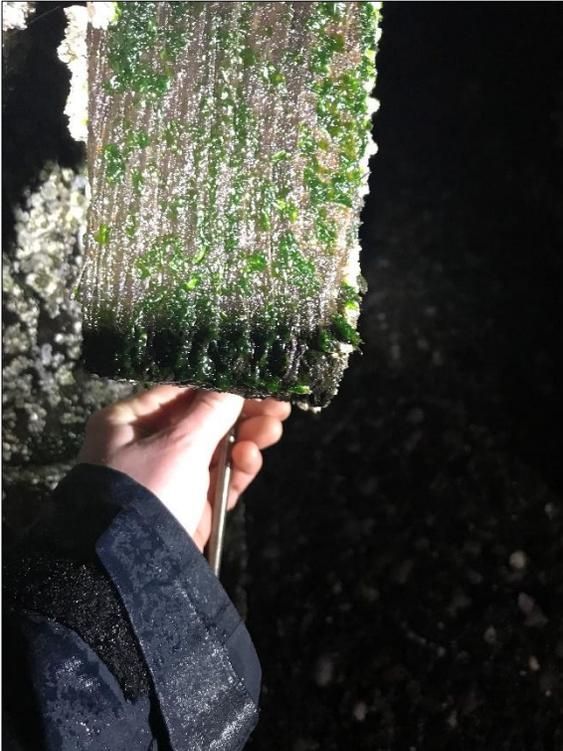
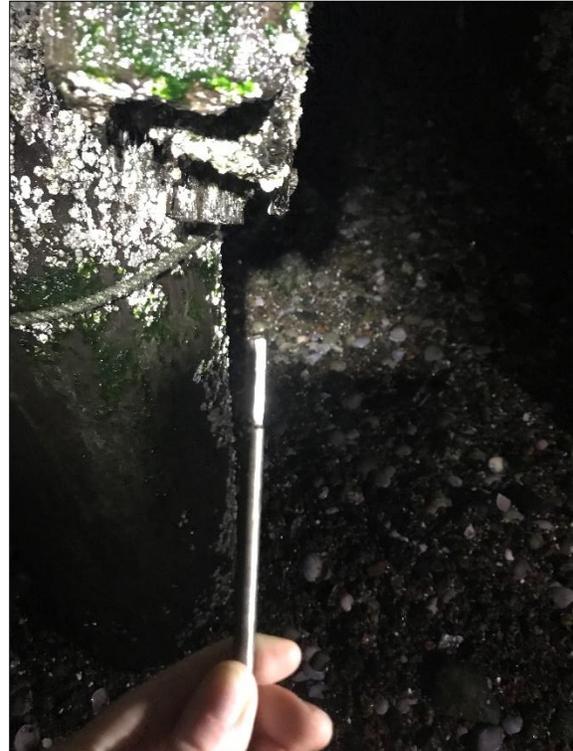
Photograph 4: Timber cross bracing, note: significant deterioration of cut ends

Six timber cross braces are recommended to be replaced utilizing the existing bolt holes to connect the new brace elements. Due to long lead times for receiving treated timber, it is acceptable to replace the treated braces with an untreated alternative, understanding that the service life will be greatly reduced due to exposure. It is recommended that the braces be D.Fir No. 1, keeping with the material type typical at marine facilities of this nature. It is also recommended that the timber have an increase edge distance of at least 300mm beyond the bolted connections to accommodate the increased rate of deterioration.

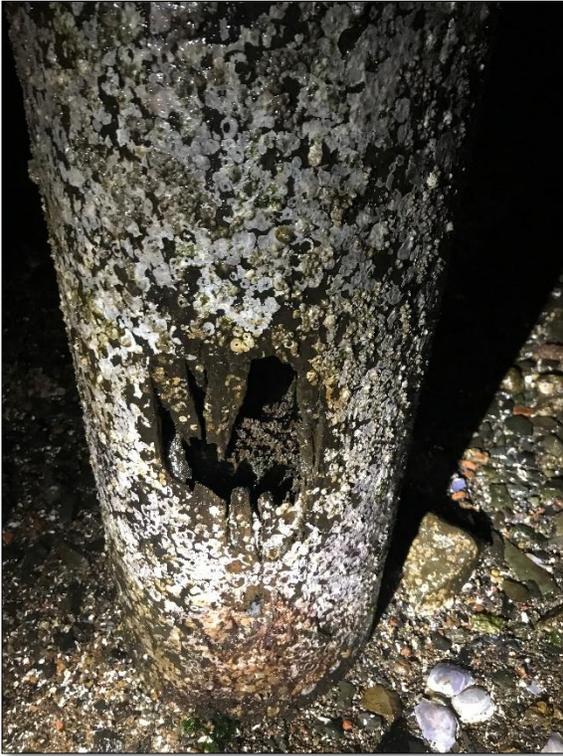
Photograph 5: Bearing Pile 4B, note: large hole with 80-90% CSL

Two timber bearing piles (2A and 4B) are recommended to be fitted with concrete grout bags, and high strength grout be injected into the bag to reinforce the compromised timber cross section. A generic detail has been appended to this report for reference.

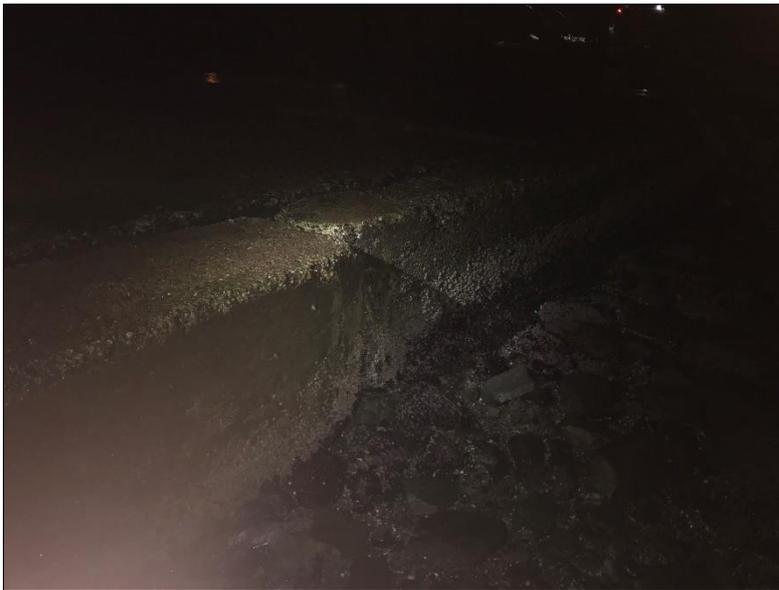
- Significant undermining of the pre-cast panels, the damage is more severe on the north aspect where the cast wall has failed. There is significant evidence of sediment transport and erosion. The cast wall is not armoured at this time.

Photograph 6: Boat ramp, note: undermining of north side of ramp

The boat ramp is recommended to be cored and concrete pumped below the panels to restore bearing. The north side of the ramp is recommended to be armoured with filter cloth and appropriately sized riprap to mitigate erosion and sediment transport.

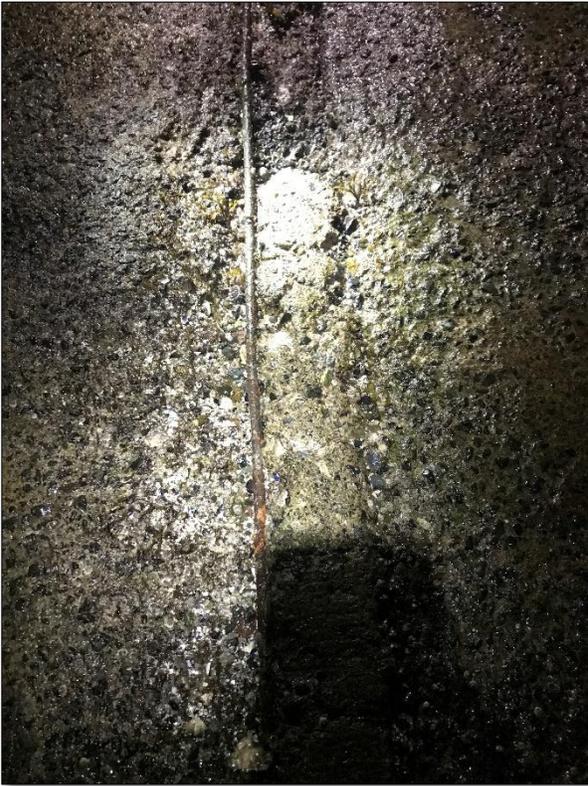
- Moderate cracking of the concrete panels due to settlement/undermining. There is visible reinforcing steel with evidence of corrosion.

Photograph 7: Boat Ramp, note: spalling of the concrete panels with exposed reinforcing
