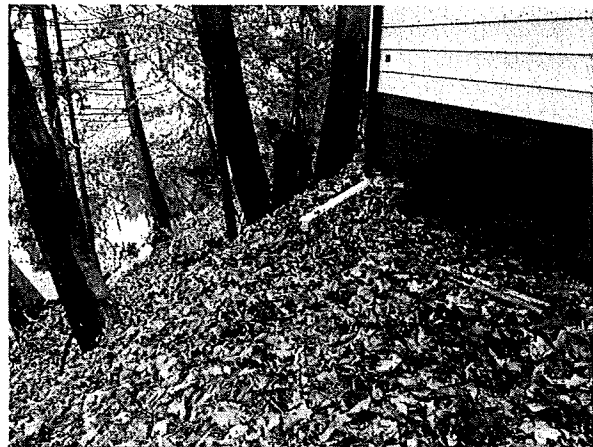
Photo 3 – Ground settlement at southeastern corner of #115

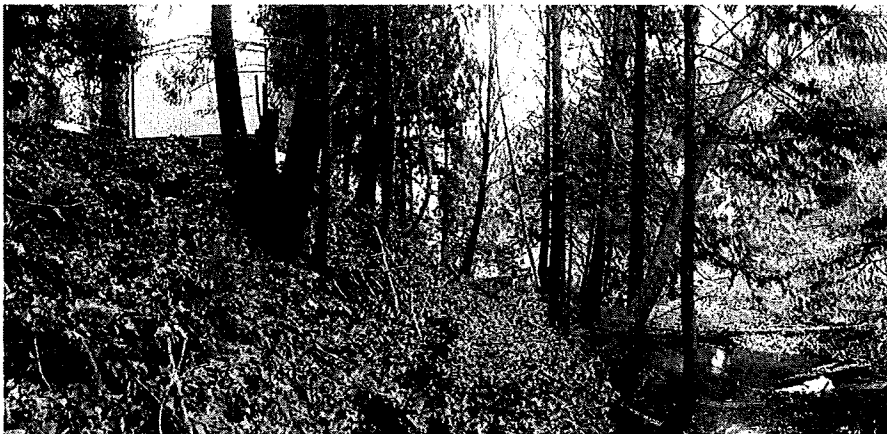
Photo 4 – Looking northwards along bank of Beck Creek adjacent to #115 showing frequent curved and leaning tree trunks indicative of slope movement

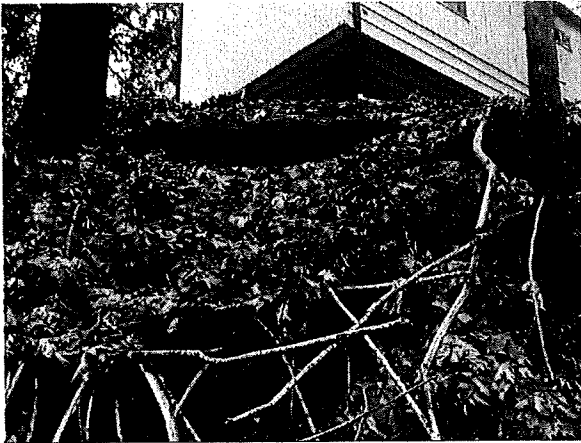
Photo 5 – Decayed log retaining structure

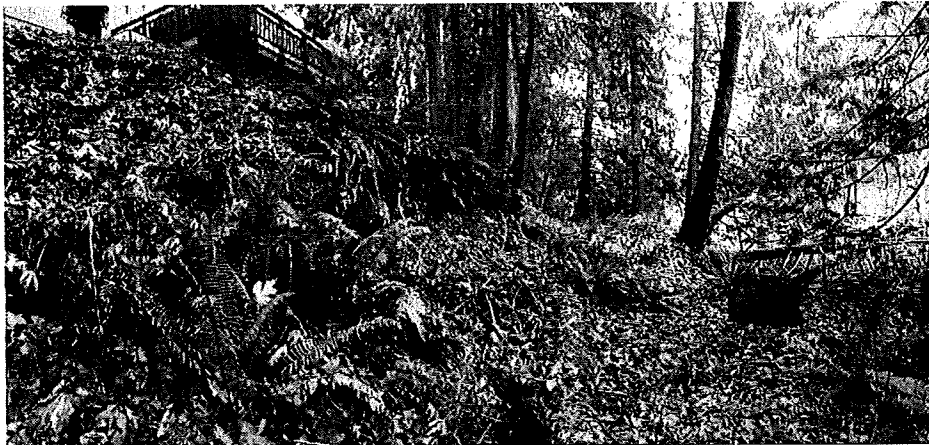
Photo 7 – gentler slope towards northern end of #115
