July 31, 2017

RE: Frank Crane Arena/Beban Social Centre Metal Cladding

RJC No. NAN.102947.0003

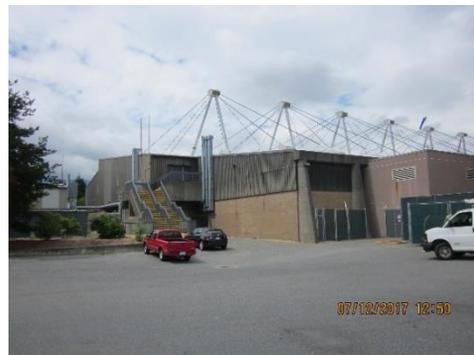
Photo 1 - View of the Arena Exterior

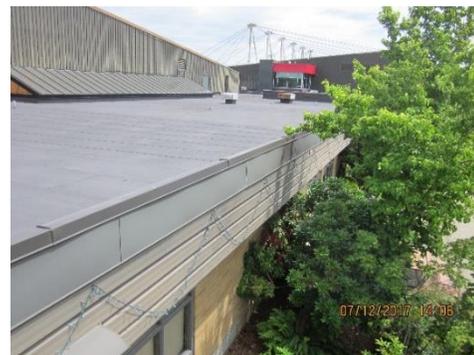
Photo 2 - View of the Walls of the Social Centre

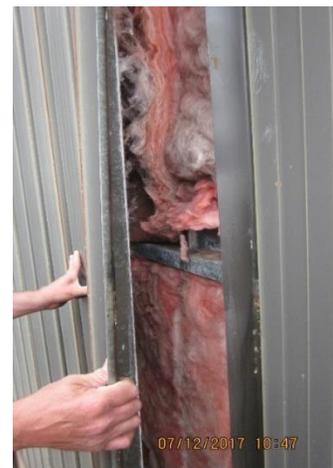
The fiberglass insulation between the back-pan and the siding was generally stained black, possibly from moisture resulting from condensation between the two layers of metal, which could be verified during winter operating conditions. This phenomenon combined with the thermal bridging caused by the metal framing could result in a substantial reduction of the effectiveness of the thermal resistance of these walls.

The backsides of the panels were galvanized, not coated. Typically, corrosion of metal panels or framing was not observed in these interior spaces between panels. White oxidation products were observed on the surfaces of the galvanized materials and the fiberglass batts inside the cavity. . This is illustrated in Photo 3 of Exploratory Opening #1 on the elevation of the Arena located in Appendix A. The conditions shown in this photograph are representative of the subsequent exploratory openings, unless noted otherwise.

Photo 3 - View of Space between Metal Siding and Metal Back-pan

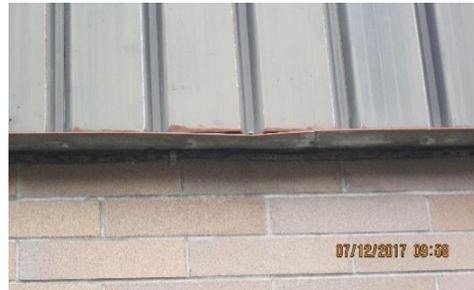
Photo 4 shows a close-up of a typical panel profile. In this instance the paint is chipped on the corner of the flutes with some surface corrosion; this occurs throughout on the panels of both buildings. In this close-up it can be seen that the coating on the face of the panels has faded. Surface corrosion was also noted in several locations on the lip at the bottom of the panel and the closure angle.

Photo 4 – Surface Corrosion at Corner of the Flutes and Flashing Angle.

The metal siding on this building has provided a long service life that can be extended by re-coating of the original factory-applied coatings with a field-applied coating system, protecting them from corrosion while enhancing the esthetics of the facades. The industry has developed procedures, performance standards and high performance coating products for over coating metal building components. The small amount of corrosion observed on the metal siding of these buildings and the heavy gauge of metal used would make this an option for renovating the metal cladding.

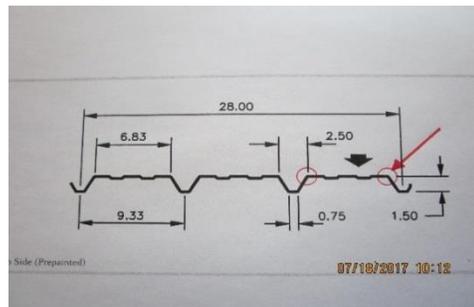
The thickness of siding was measured to be 16 gauge and with profile dimensions that are very similar to the section shown in Photo 5, copied from a current catalogue. Most of the wear and tear was noted on the corners of the flutes (marked in this picture). This was observed to occur on panels all around the buildings but was more prevalent on walls with southern and western exposure to UV radiation from the sun

Photo 5 – Typical Panel Profile

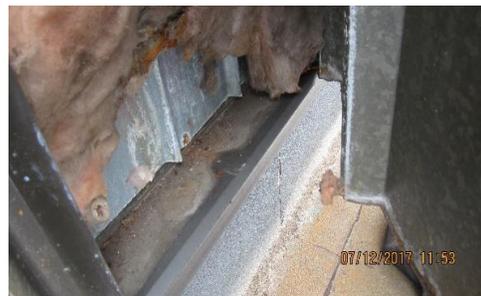
Drawing details show spaces of different width between the masonry walls and the metal panel assemblies, thus providing a drainage cavity. As most of these spaces are shown to be seven inches or more in width, they are likely to act as an air plenum rather than a drainage cavity. This was manifested at Exploratory Opening #2 (refer to the Arena elevation drawing in Appendix A) at a wall enclosing the swimming pool where warm air with a strong chlorine odor was noticeably blowing through this opening to the exterior (Photo 6).

Photo 6 – Warm Air Smelling of Chlorine blowing from Wall.

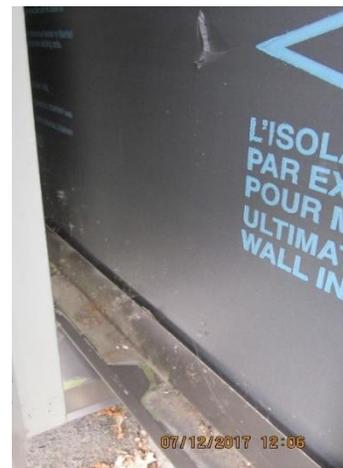
The small addition in the area of the Arena lobby was constructed similar to the remainder of the building, except that the type of thermal insulation used was rigid foam that appeared to be in good condition (Photo 7).

Photo 7 – Rigid Foam Insulation used at Addition

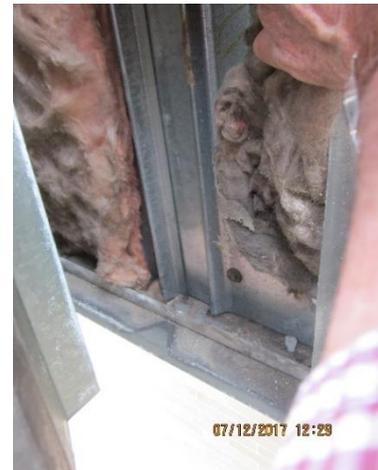
A fibre cement panel was removed from the soffit of the arena along the bottom of the metal wall running parallel to Bowen Road revealing a wide open space between the metal siding and the masonry wall of the arena. Refer to Exploratory Opening #5 of the Arena Elevations in Appendix A. A thin layer of fibreglass batt insulation was attached to these panels. No corrosion was found on the steel framing or metal siding assembly at the interior space between the metal siding assembly and the concrete block masonry walls. Refer to Photo 8 and Photo 9 (next page).

Photo 8 – Fibre Cement Soffit Panels

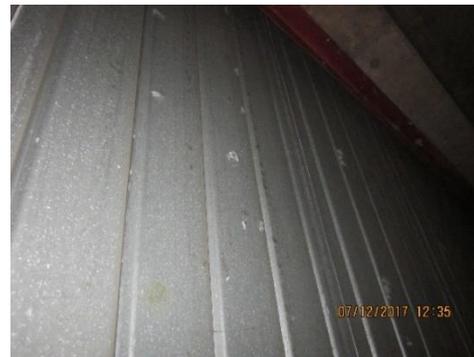
Photo 9 – Fibreglass Insulation between Back-panels and Metal Siding.

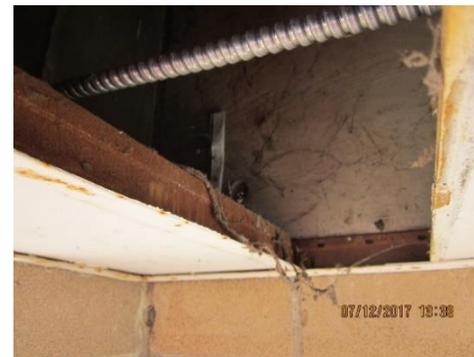
Some of the fibre cement soffit panels of the Social Centre were removed to review the condition of the metal siding. Refer to photograph #10. No anomalies with the siding were observed, however the T-Bar suspension system supporting the soffit panels is severely corroded and may require replacement in the near future to avoid dislodging of the panels and possibly resulting in a safety concern (next page; Photo 10).

Photo 10 – Corroded T-Bar in the Soffit of the Social Centre

In this case, RJC recommends that the soffit panels and their suspension system on both buildings be replaced to avoid dislodging of the panels which present a safety concern.

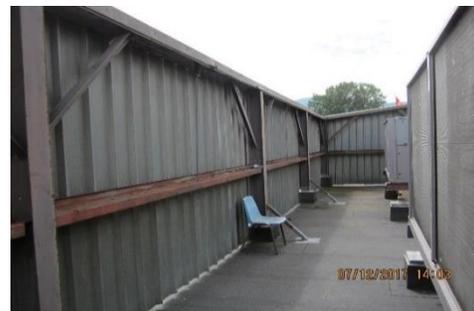
The metal siding panels on the Social Centre exhibited the same features that were observed and recorded for the Arena building. There is surface corrosion on the exposed structural framing supporting the metal cladding on the roof enclosing the mechanical equipment (Photo 11). Cleaning and coating of the structural members would extend the service life of this structure.

Photo 11 – View of the Equipment Enclosure at Roof of the Social Centre
