April 08, 2021

**RE: Nanaimo Aquatic Centre Parapet Repairs
Mechanical Mezzanine Roof**

RJC No. NAN.101523.0006

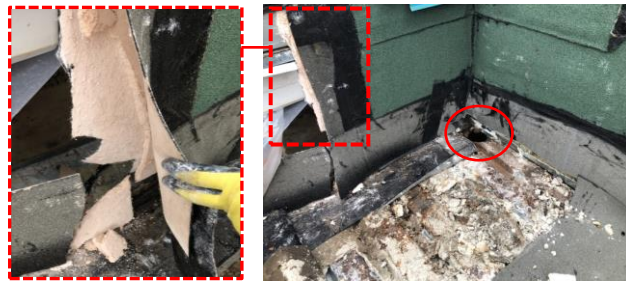
Photo 1: Location 1; Hole in the Q-deck circled in red, deteriorated gypsum sheathing on the surface of the roof and at the parapet. Inset shows damage to Phase 1 gypsum sheathing at the parapet wall.

At RJC's request, the contractor removed two sections of roof sheathing, allowing RJC to review the underlying condition of the Q-deck (Locations 1 and 2, Figure 1). The roof sheathing at Location 1 had failed and could be crumbled by hand (Photo 1). Adjacent parapet sheathing that had been previously replaced as part of the Phase 1 work in 2020, had also failed. At the parapet, the fibreglass facing of the new gypsum sheathing easily separated from the gypsum core, and the gypsum core was saturated with water (Photo 1, inset).

Based on its condition, RJC recommends replacing the existing roof sheathing at the mechanical mezzanine with new, fibreglass-faced gypsum sheathing. This new sheathing would be fastened to the existing Q-deck in accordance with the wind uplift requirements of the BC Building Code. The roofing system previously specified could then be installed on this new substrate.

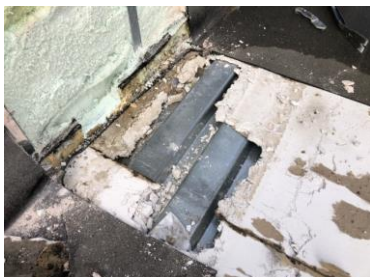
During the March 25th investigation, two additional areas of roof and upstand wall sheathing were removed (Locations 3 and 4, Figure 1). Based on the findings at these locations, along with Location 1, and a visual review of the remainder of the roof sheathing adjacent to the upstand wall, it appears that the strip of existing roof sheathing adjacent to the upstand wall has failed, and will require replacement (Photos 1, 2, 3, and 4).

Photo 2: Location 3; deteriorated gypsum sheathing.

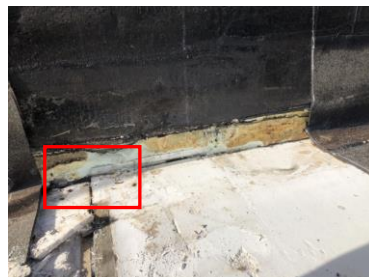
Photo 3: Location 4; deteriorated gypsum sheathing. Refer to Photo 5 for close up of indicated area.

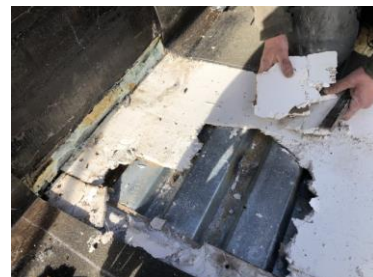
Photo 4: Location 4; deteriorated gypsum sheathing.

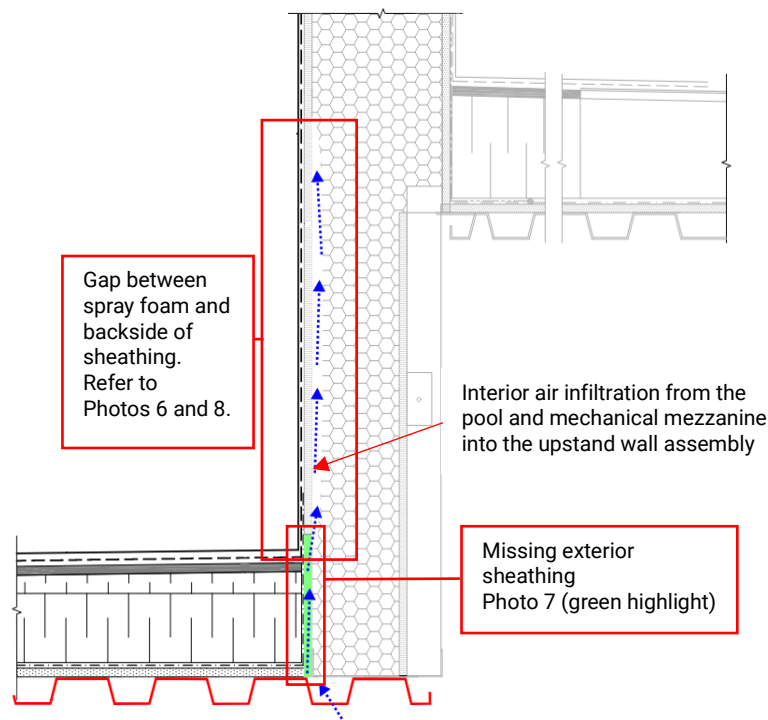
Figure 2: Section at the upstand wall.

When completing Phase 1 work, the roofing assembly at the mechanical mezzanine was still in place. The old parapet wall was removed, and a new parapet wall was framed in its place without removing the mechanical mezzanine roofing. Spray foam insulation was applied between the new studs, down to the sill track. New sheathing was installed, but since the existing roof was still in place, the sheathing did not extend down to the structural decking as shown in the Contract Documents (Figure 2, Photo 6 and 7). The resultant gap is visible in Photo 7, creating a void at the bottom of the upstand wall assembly interconnecting each stud cavity and allowing warm, moisture-laden air to circulate to the exterior side of the new upstand wall assembly where it would cool and the water vapour condense.

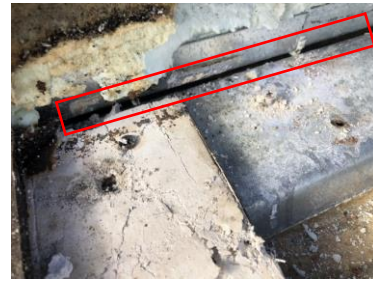
In addition, the new gypsum sheathing installed on the upstand wall at Locations 3 and 4 as part of Phase 1 in 2020 has been exposed to excessive moisture and should also be replaced. The source of this moisture appears to be an unsealed gap between the new track assembly and the adjacent flute of the Q-deck (Photo 5). The air within the flutes of the Q-deck is conditioned to the interior air of the mechanical mezzanine, which has similar characteristics to the pool hall; warm air, with a high relative humidity.

Photo 5: Location 4; sheathing shown in Photo 4 was removed on the right side of the photo exposing the gap outlined in red.

RJC recommends an air seal be added as a precautionary measure, bridging from the vapour retarder on the roof sheathing onto the steel stud track. This could be accomplished with a metal angle that transitions from the horizontal roof surface to the metal track with foam tape and fasteners (Figure 3 Inset). This seal would then be picked up by the spray foam to transition to the air/vapour retarder at the underside of the main roof, previously completed as part of Phase 1.

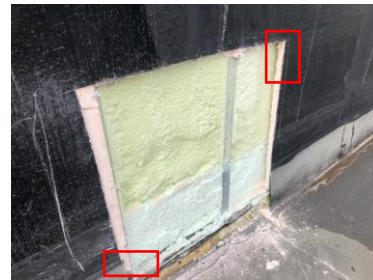
Photo 6: Location 3; new sheathing on the upstand wall was removed exposing a gap between the face of the spray foam and the backside of the sheathing (top right red rectangle, shown in Photo 8). Missing sheathing was also confirmed at the bottom of the recess (bottom left red rectangle, shown in Photo 7).

To address the moisture within the upstand wall, RJC recommends the removal of the new exterior sheathing and spray foam insulation. In order to regain intimate contact between the spray foam and the steel studs, cleaning of the studs and track to bare metal will be required. Removal of the steel stud framed wall and replacement of the entire assembly may be less time consuming.

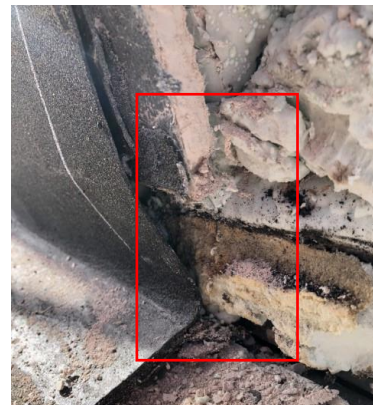
Photo 7: Missing sheathing at the base of the upstand wall. The new vapour retarder was not adhered creating a void the length of the upstand wall.

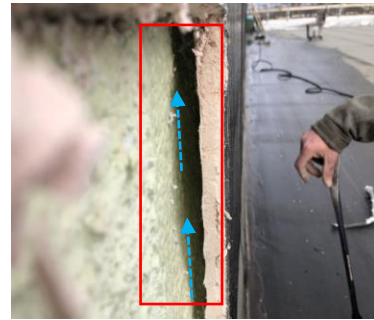
In addition, a review of the spray foam revealed that it did not completely fill the stud cavities, nor was it in intimate contact with the gypsum sheathing (Photo 8).

Photo 8: Close up of the gap shown in Photo 6 and Figure 2.

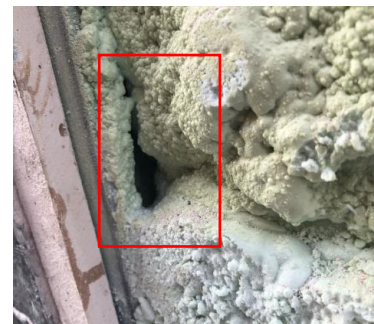
In one exposed location, a void was observed in the spray foam (Photo 9). This void would further facilitate the movement of interior air within the upstand wall.

Photo 9: Void in the spray foam application. It is unknown how far the void extends.

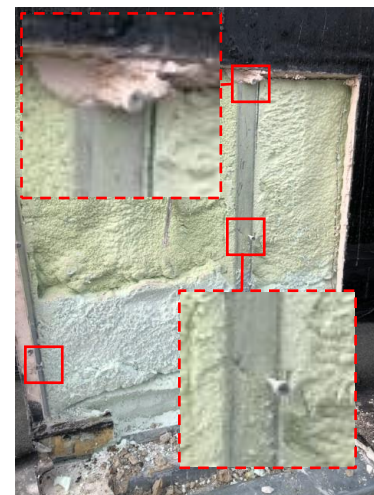
Based on our review, it appears that the fastening of the existing sheathing is insufficient to meet the current wind uplift requirements noted within the BC Building Code. Similar pull-through of fasteners was observed at the upstand wall, where the new sheathing pulled through the fasteners used to secure the sheathing (Photo 10). As the sheathing at the upstand wall has also been damaged by moisture, it should be replaced. Although the visible moisture damage in the field of the roof is minimal, the sheathing's structural integrity appears to have been compromised by what moisture has penetrated and it should be replaced throughout the mechanical mezzanine roof.

Photo 10: Fasteners in the new sheathing could be pulled through the sheathing with minimal effort.

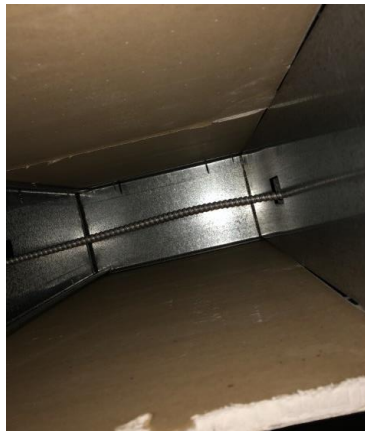
Location 6 was selected based on its proximity to the discolouration observed within the parapet wall and Location 7 was selected based on its proximity to the discolouration at the west louver previously reviewed with the City. No organic growth or moisture damage was observed within either of the wall cavities reviewed (Photos 11 and 12). It appears that the observed organic growth within the parapet is limited to the parapet assembly. Refer to email correspondence sent March 17, 2021 for more information on the sheathing deterioration at the west louver.

Photo 11: Location 6; no damage observed within the wall cavity.

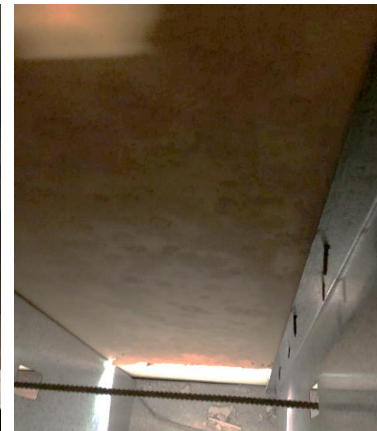
Photo 12: Location 7; no damage observed within the wall cavity.
