**Re: Townsite Road Chinese Cemetery
Gateway & Pagoda Condition Assessment**

Herold Engineering Limited (Herold Engineering) is pleased to submit this report on the concrete condition assessment of the two concrete structures located in the Townsite Road Chinese Cemetery at 1598 Townsite Road, in Nanaimo, BC.

NANAIMO TOWNSITE ROAD CEMETERY GATEWAY ASSESSMENT

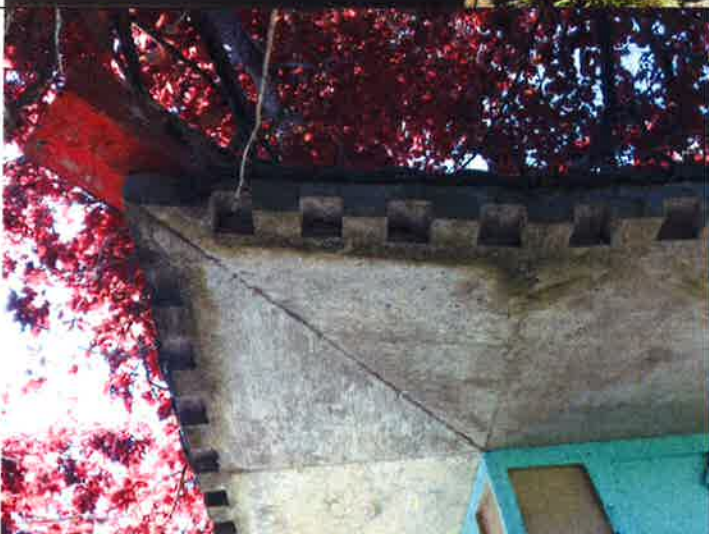
- 1) Concrete Damage – There appears to be three general types (and associated locations) of damage present within the two structures:
 - a. Roof slab edge cracking/spalling – These cracks were relatively wide, often with exposed reinforcing just below the surface and were observed extensively along the architecturally formed roof slab edges of both structures. (See Photos 5, 6 & 7)

Photo 5 – View of the architecturally formed roof slab edges

- 1) The damage to the edges of the roof slabs on both structures as noted above require repair. Much of the damage is loose overhead and poses a falling hazard. Repair of this damage will typically include removal of loose/deteriorated concrete, replacement of deteriorated reinforcing steel, installation of galvanic anodes and patching with an appropriate repair mortar/concrete.

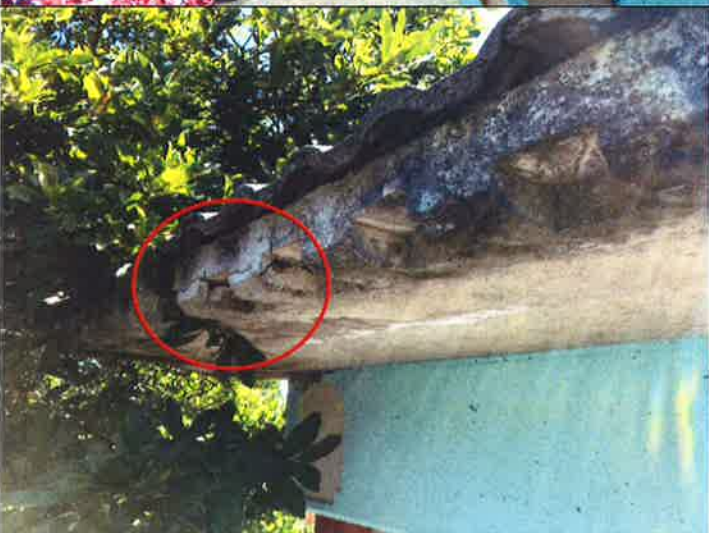
Along the architecturally formed edges of the roof slabs, the concrete cover was typically within the range of 0 mm to 10 mm where block outs had been formed in the concrete, compared to ~50 mm cover typically around the rest of the concrete members in both structures. At these locations, it is likely that the concrete carbonation has progressed past the depth of reinforcing steel, resulting in the widespread cracking/spalling and corroding reinforcing steel observed.

- 1) The cracking/spalling along the edge of the roof slabs is likely due to the corroding and expanding reinforcing steel, which is expected from the combination of largely reduced concrete cover and concrete carbonation.

Photo 6 – View of typical cracking/spalling along the roof slab edges

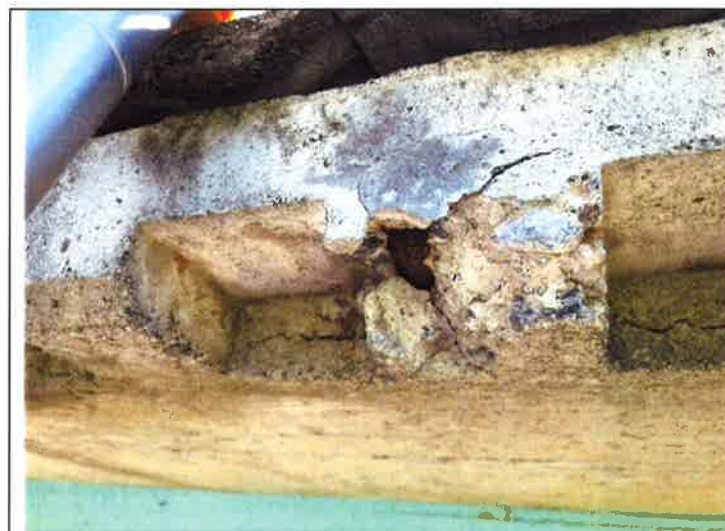
Photo 7 – Close view of typical roof slab edge cracking/spalling with exposed reinforcing steel

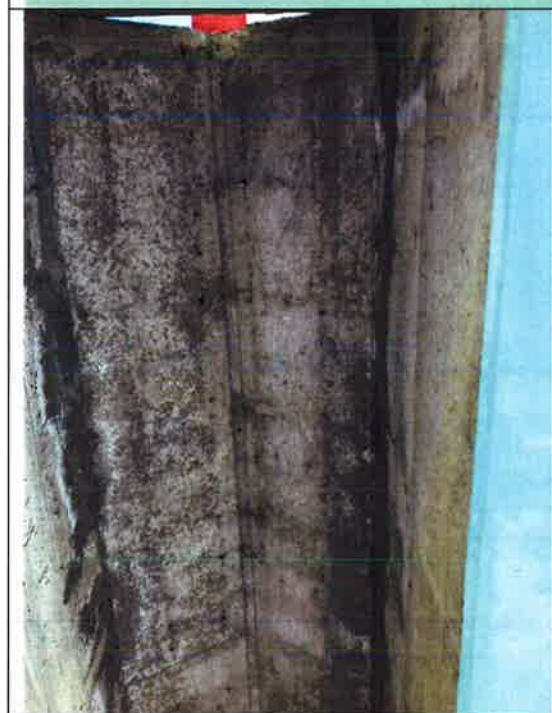
- b. Roof slab honeycombing – Concrete voids of varying extent with exposed reinforcing and reinforcing ties observed on the underside of both roof slabs. (See Photos 8 & 9)

- 2) The concrete honeycombing noted on the underside of the roof slabs is likely the result of improper vibration and/or distribution of the concrete during construction. These voids present further opportunity for corrosion of the reinforcing steel and carbonation.

Photo 8 – View of typical concrete honeycombing on underside of Gateway roof slab

- 2) In areas where honeycombing is present on the underside of the roof slabs, it is recommended that the voids be cleaned and patched with an appropriate repair mortar/concrete. Where corroded reinforcing steel is discovered, replacement of the deteriorated reinforcing steel and installation of galvanic anodes is recommended.

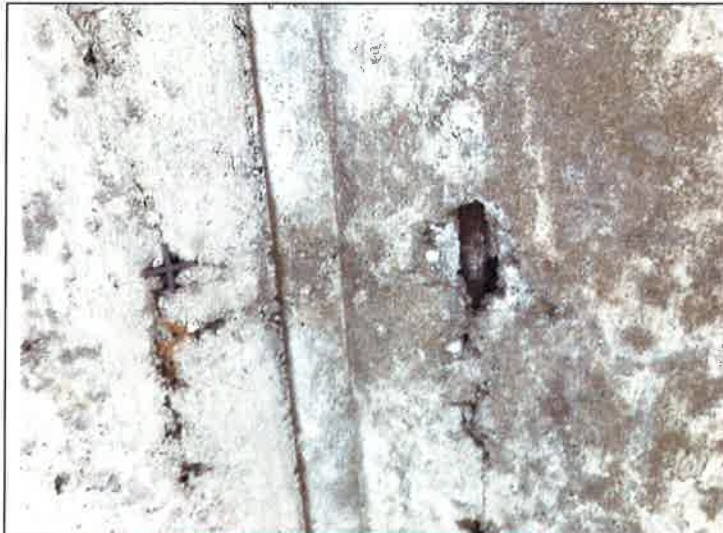
Photo 9 – Close view of concrete honeycombing/voids in Gateway roof slab with exposed ties and reinforcing steel

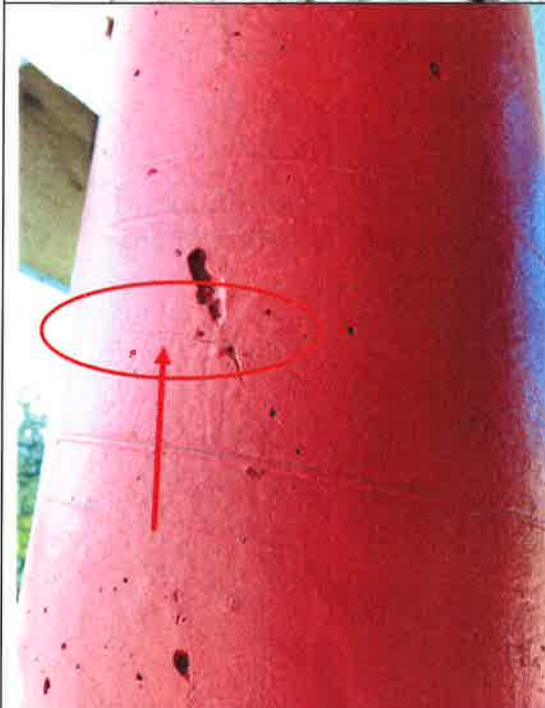
- c. Column cracking – These cracks were relatively narrow in width and minor in extent and were observed in multiple locations on all four Gateway columns. (See Photo 10)

- 3) The minor cracking noted on the four gateway columns may be the result of early stages of stirrup corrosion, as horizontal reinforcing was noted behind each of the observed cracks where the typical concrete cover was ~40 mm. In any case, these cracks present a pathway for further carbonation.

Photo 10 – View of a typical minor crack in the Gateway structure columns

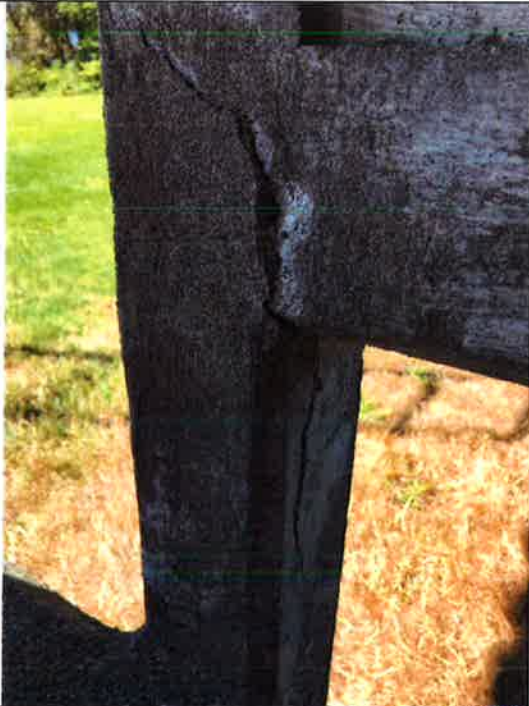
- d. Miscellaneous cracking/spalling – Isolated areas of concrete cracking or spalling, noted in various locations on both the altar and shrine under the Pagoda structure and in two locations on the Pagoda ridge beams. (See Photos 11 & 12)

Photo 11 – Close view of cracking/spalling on Pagoda altar

- 5) Upon removal of the Gateway roof tiles, it is recommended that the timber framing supporting the tiles be removed and replaced.
- 6) It is recommended that all areas of miscellaneous concrete damage be repaired, including the cracking and spalling noted on the Pagoda altar and shrine, as well as the exposed reinforcing noted in two locations on the Pagoda ridge beams.

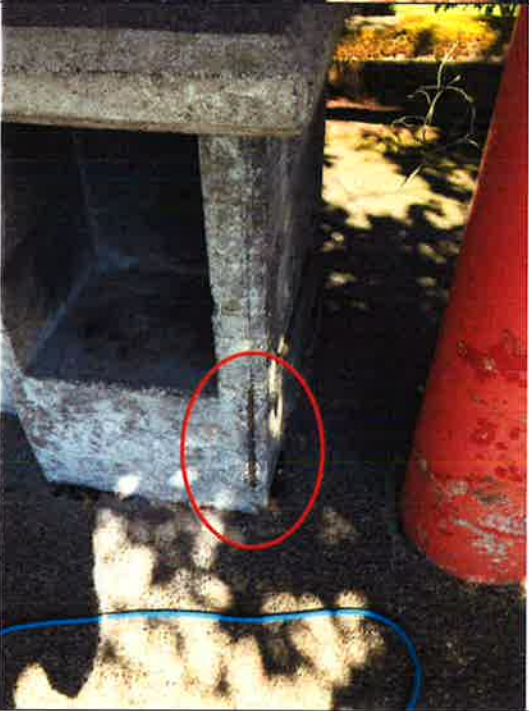
Photo 12 – View of exposed reinforcing steel on Pagoda shrine

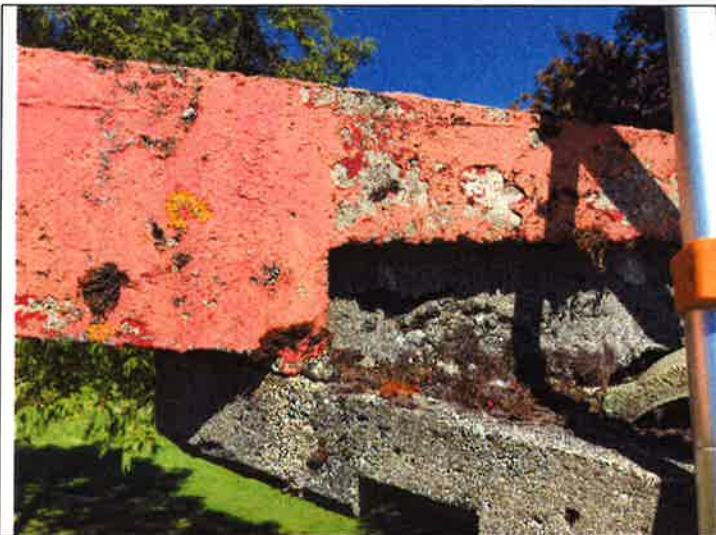
- 2) Coating Failure – In general the painted coatings on both structures were found to be failing with widespread cracking and peeling noted. (See Photos 13 & 14)

- 4) The general failure of the painted coatings on both structures is likely the result of the age and exposure of the structures, causing the coatings to crack and peel throughout.

<p>Photo 13 – Example of the typical condition of the existing painted coatings (Pagoda ridge beam)</p>

- 3) It is recommended that all existing painted coatings be removed and repainted. In general, it is recommended that all exposed concrete be painted or sealed on both structures.

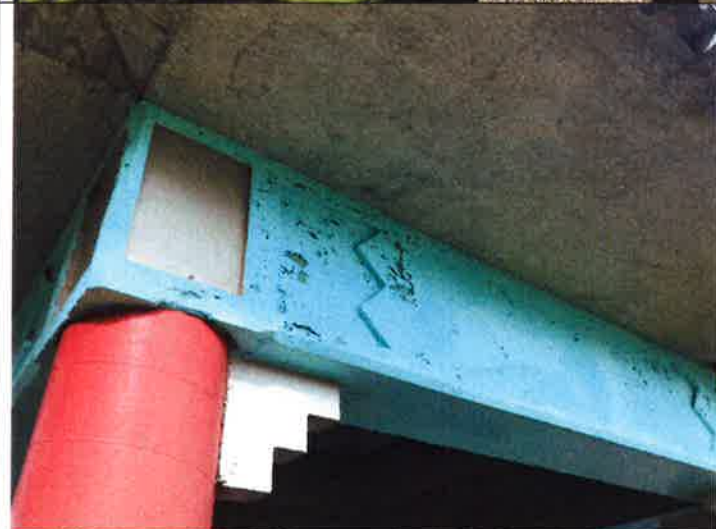
<p>Photo 14 – Example of the typical condition of the existing painted coatings (Gateway beam)</p>

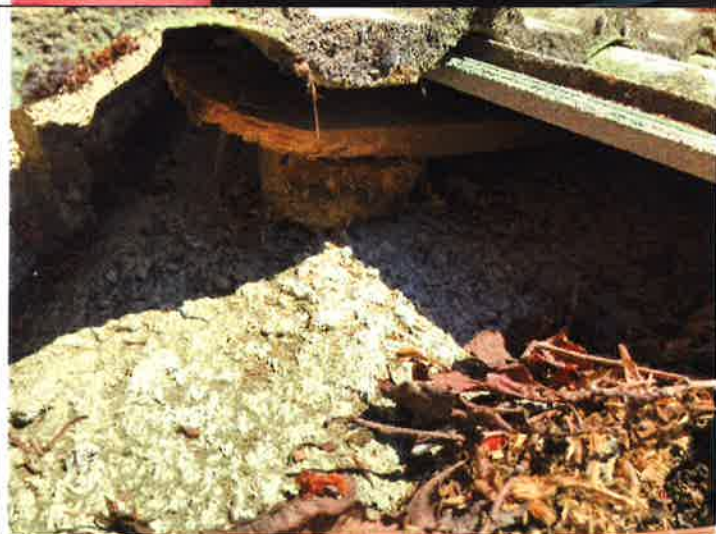
- 3) Timber Deterioration – The timber nailing strips which support the concrete roof tiles on both structures are generally at or nearing the end of their service life. (See Photo 15)

- 5) The noted deterioration of the timber strips supporting the concrete roof tiles may be a result of exposure to moisture and/or fungal attack, however it is unclear whether or not the timber members were treated and if so, whether any treatment remains.

<p>Photo 15 – View of the deteriorated timber members supporting the roof tiles</p>

- 4) It is recommended that the roof tiles be removed from both structures in order to seal the topside of the concrete roof slabs and to replace the deteriorated timber nailing strips with new pressure treated members. Prior to reinstalling the roof tiles, it is recommended that the tiles be cleaned free of moss and other accumulated debris.
