ATTACHMENT A

840 ST. GEORGE STREET

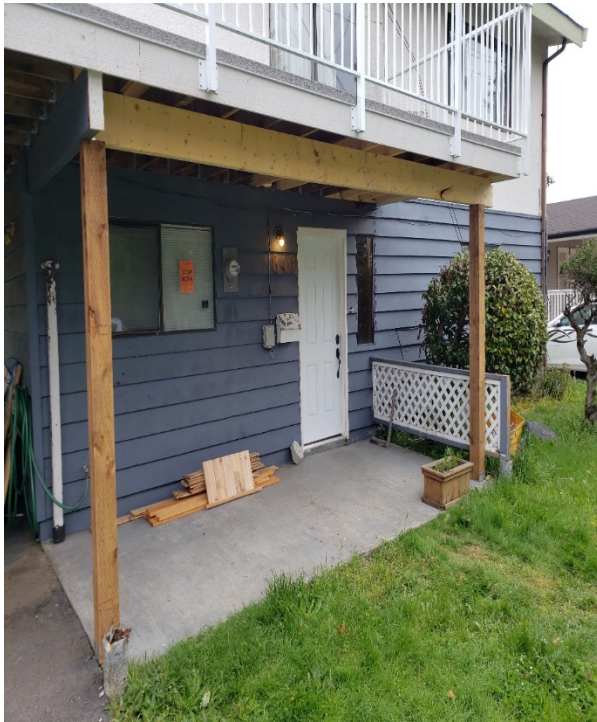
Columns are undersized and not founded on proper foundations.

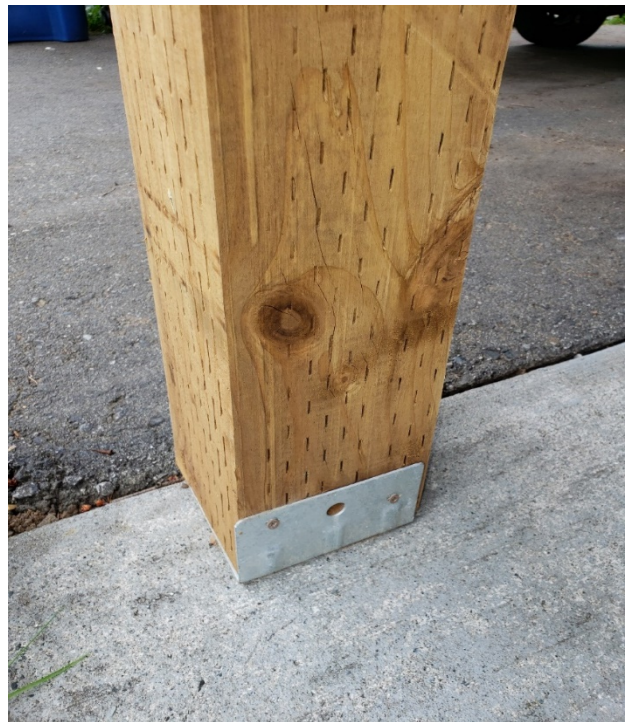
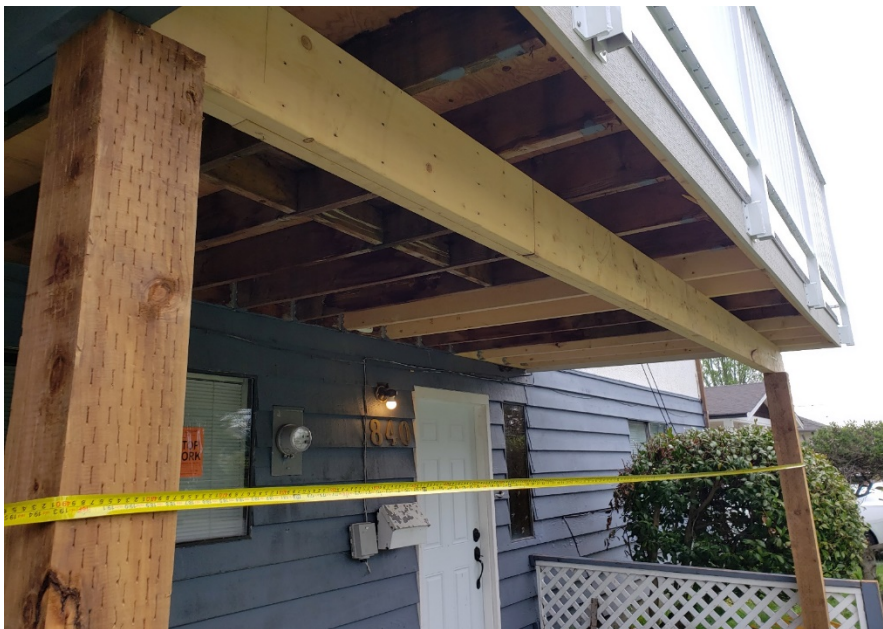
Beam is spliced mid-span on both members, relying solely on the shear strength of the fasteners.

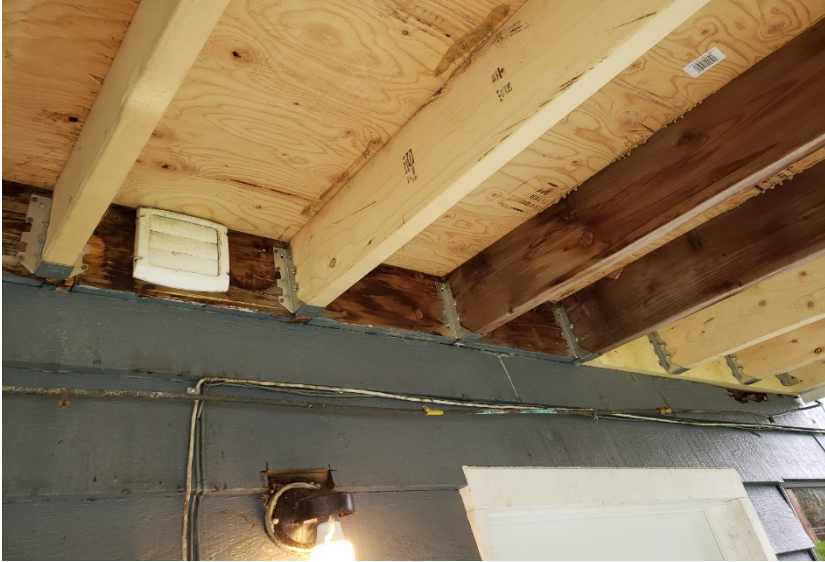
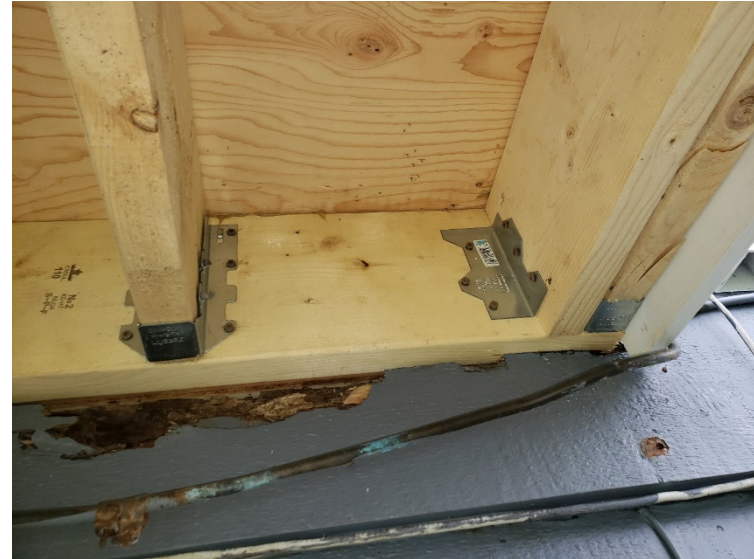
Joists are improperly installed with screws instead of nails. Screws have very little shear value.

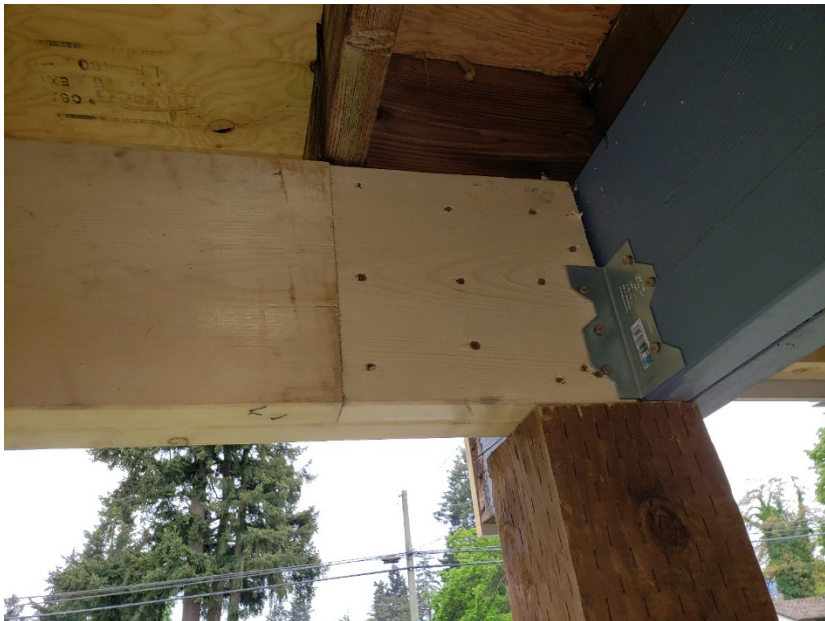
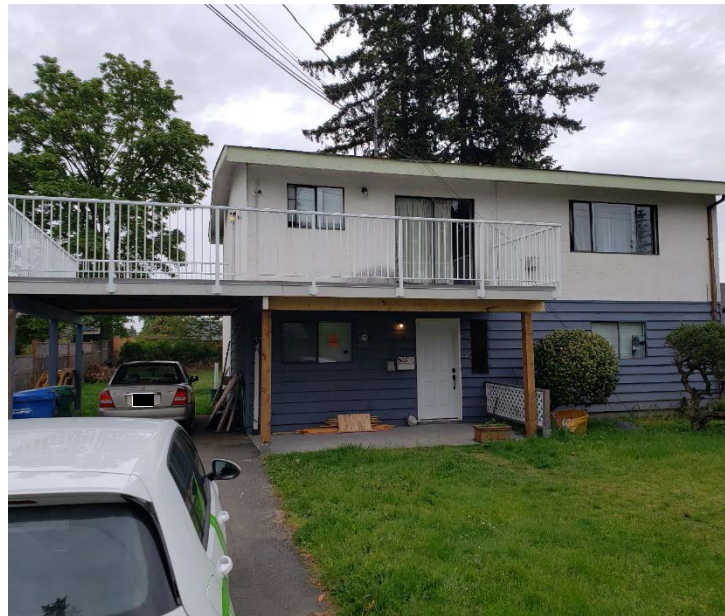
2-ply beam spliced incorrectly with deck screws.
