**Risk Assessment of Two Black Cottonwoods  
at Georgia Avenue at the south east corner of 577 6<sup>th</sup> Street**

The City of Nanaimo is planning to construct a new bridge across Chase River to connect the North East corner of Harewood Centennial Park to Georgia Avenue. Close to the planned alignment there are two large black cottonwood trees on the north bank. Dunster & Associates has been asked to conduct a risk assessment of these two trees to determine if they are suitable for retention.

The site was visited on May 1<sup>st</sup> 2018. Julian Dunster met with Kurtis Noble from the engineering department to discuss the project. Each tree was visually assessed and then a Level 3 assessment was undertaken using sonic tomography and resistance drilling to explore the inner conditions of each tree.

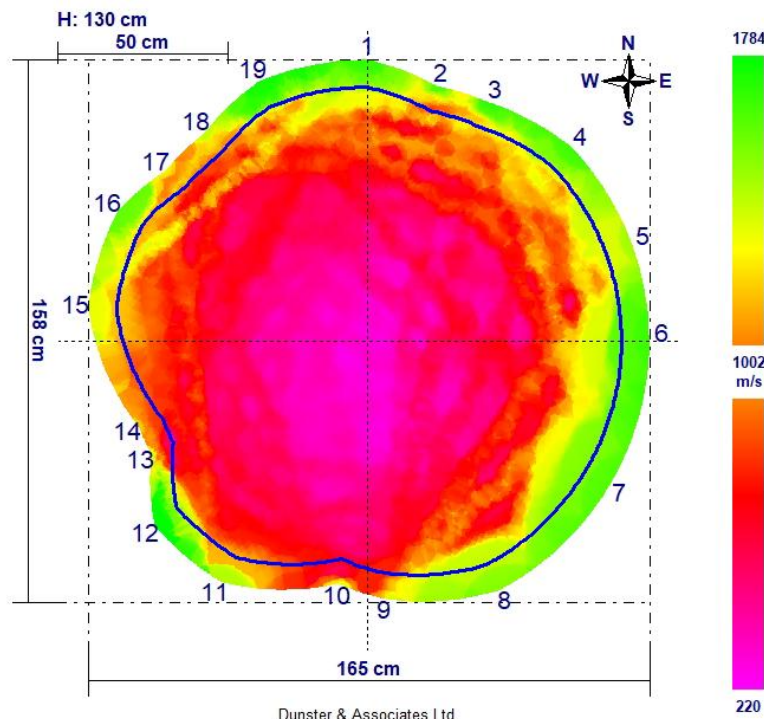
Figure 3. Tomogram of tree # 1.

Nineteen sensors were used to gain an image. Figure 3 shows the resulting tomogram. The low velocity data (purple) represents areas of decayed or missing wood (possibly hollow). The high velocity data (green) represents solid wood in good condition.

The tree trunk has very extensive decay across the entire trunk. In this test I have set the shell wall thickness line (the blue line on the tomogram) to 10%. Strength loss calculations in the Arbotom software suggest that there is a average 48% loss of strength in the trunk when the wind was blowing from the south west to the north east. The Resistograph7 tests confirm that there is only 11 centimetres of solid wood at sensor 16 and 20 centimetres at sensor 7.

Overall the tree trunk is close to vertical, and there is a high crown with very little dieback. The base of the tree trunk has several pronounced flares, which likely represent response growth (new wood) being added onto the base of the tree to offset the internal decay which will go to the ground and extend upwards for several metres above the test point.

- 3        Consider creating wildlife trees. This only applies to tree # 1. Because both trees are in a riparian area I expect that removal will require use of a crane to avoid dropping materials into the river. To convert tree# 1 into a good wildlife tree remove the crown and retain a trunk about 10 metres high. Jag up the top cut surface of the trunk. That would leave a large standing column of wood. To add an extra degree of safety I would attach steel cables to the trunk at a point several metres below the top. Those cables would be attached to the ground downstream on either side of the bank and would act to prevent a collapse of the trunk onto the bridge. The tree trunk would then become an excellent habitat for owls, woodpeckers and other bird life. Tree # 2 leans too far and is not suitable for a wildlife tree.

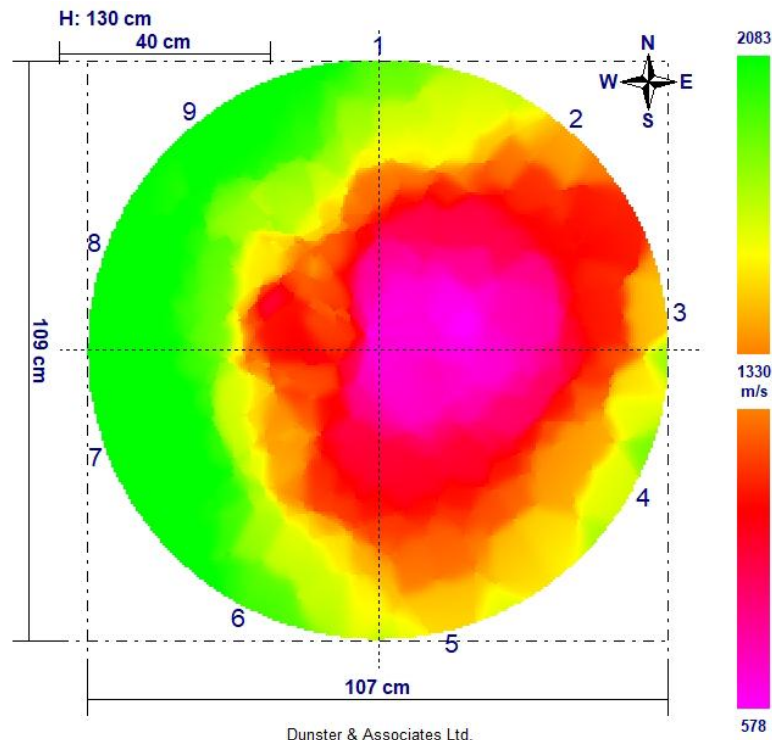
Figure 6. Tomogram of Tree # 2.

Nine sensors were used to gain an image. Figure 6 shows the resulting tomogram. The low velocity data (purple) represents areas of decayed or missing wood (possibly hollow). The high velocity data (green) represents solid wood in good condition.

There is an offcentre column of decay extending towards the east side. The tree leans southwest so the decay area is more on the tension side of the structure. Strength loss calculations in the Arbotom software suggest that there is an average 27% loss of strength in the trunk when the wind was blowing from the north east to the south west. The Resistograph7 tests confirm that there is only 7 centimetres of solid wood at sensor 3. On the tension side at sensor 7 there is about 45 centimetres of sound wood.

The tree leans over considerably and has a couple of areas of obvious crown dieback. The base of the tree trunk is quite symmetrical suggesting that the decay column may not be as extensive towards the ground or above the test point. There is an old wire rope embedded into the tree trunk close to the ground. The south side of the root mat is at the edge of the bank and slightly undermined. It appears to have been in that condition for a long time and is adapted to that setting.

Both trees have columns of decay in their trunks. Both trees are rated as a high risk once construction starts and the bridge is completed. Tree # 2 should be removed in its entirety. Tree # 1 could be retained as a wildlife tree.
