**SUBJECT | DOWNTOWN SIDEWALKS AND TREE REPAIRS**

### **Purpose of Report**

To provide Council with an opportunity to repair and restore sidewalks that have localized tree root damage in the Downtown. |

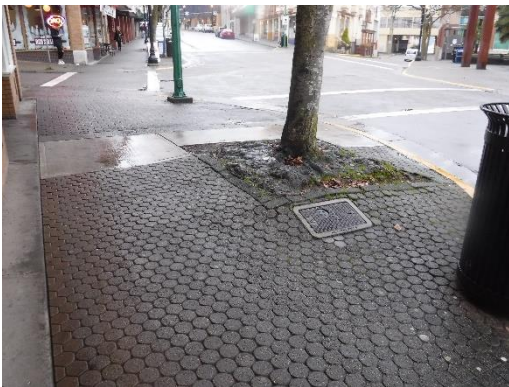
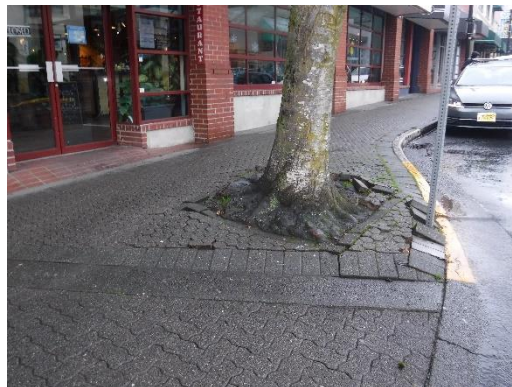
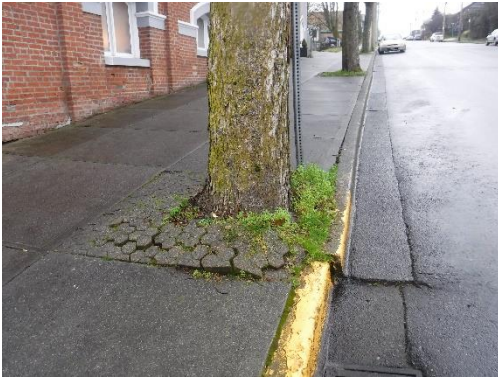
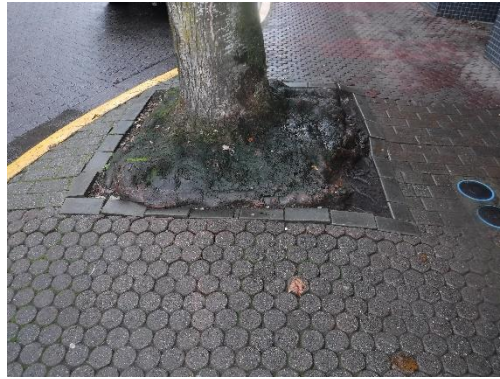
Within Downtown Nanaimo, there are approximately 300 boulevard / decorative trees of varying species, age, and condition. Many of these trees are located in close proximity to sidewalks and other areas provided for pedestrians. It is common, over time, for the tree roots to damage the sidewalk such as lifting concrete panels, bricks or curbs. This can create a trip hazard and can make the walking surface undesirable especially for those with mobility challenges. The damaged sidewalk areas are often very localized around the tree, and only require repair in the root zone; however, the tree itself presents an obstacle to the repair.

Examples of tree sidewalk heaving:

When sidewalks are heaved or damaged by roots, a trip hazard can result. Although Staff respond to these hazard reports in accordance with the City's defined level of service; it is not practical to completely eliminate the risk since it is an ongoing process, as the tree grows.

Remove trees, remove damaged sidewalk, install tree root cell structure, restore sidewalk and plant new suitable trees.

2. Skinner Street near Bastion Road – East side of Skinner there is a Linden tree with structural damage that needs to be removed. Unfortunately, the sidewalk width in that location is insufficient to provide universal accessibility with a tree present. That tree will be removed and the sidewalk restored.
3. A trial using rubberized asphalt at the base of some trees around the Vancouver Island Conference Center will be undertaken. The rubberized asphalt is expected to be effective; however, it may not last more than a few years.
