April 08, 2021

**RE: Nanaimo Aquatic Centre Parapet Repairs
Mechanical Mezzanine Roof**

RJC No. NAN.101523.0006

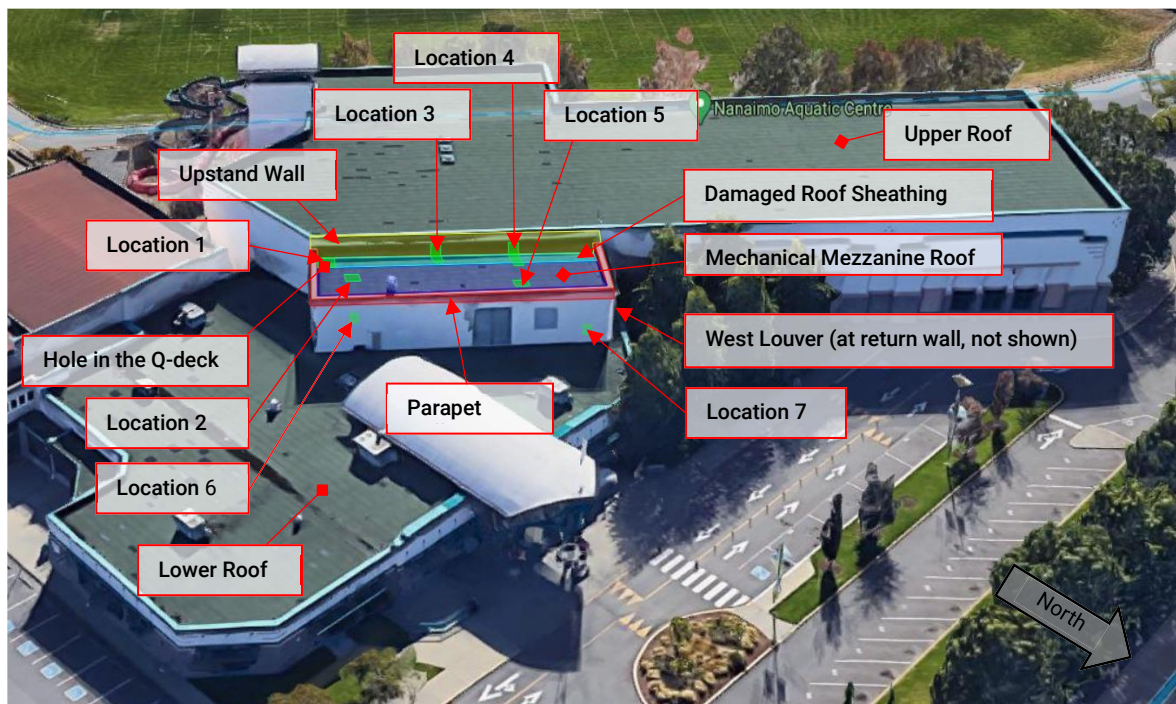
Figure 1: Orthographic view of NAC, highlighting the mechanical mezzanine roof. Language used in this report to identify other components are also included.

At RJC's request, the contractor removed two sections of roof sheathing, allowing RJC to review the underlying condition of the Q-deck (Locations 1 and 2, Figure 1). The roof sheathing at Location 1 had failed and could be crumbled by hand (Photo 1). Adjacent parapet sheathing that had been previously replaced as part of the Phase 1 work in 2020, had also failed. At the parapet, the fibreglass facing of the new gypsum sheathing easily separated from the gypsum core, and the gypsum core was saturated with water (Photo 1, inset).

During the March 25th investigation, two additional areas of roof and upstand wall sheathing were removed (Locations 3 and 4, Figure 1). Based on the findings at these locations, along with Location 1, and a visual review of the remainder of the roof sheathing adjacent to the upstand wall, it appears that the strip of existing roof sheathing adjacent to the upstand wall has failed, and will require replacement (Photos 1, 2, 3, and 4).

In order to determine if the organic growth at the parapet walls extended into the main walls of the mechanical mezzanine, two interior recesses were made (Locations 6 and 7, Figure 1). Due to the mechanical equipment in place, access to exterior wall areas was limited.
