ADDENDUM
SPECIAL OPEN COMMITTEE OF THE WHOLE MEETING
SHAW AUDITORIUM, 80 COMMERCIAL STREET, NANAIMO, BC
MONDAY, 2015-JUL-06, AT 4:30 P.M.

REPORT TO COUNCIL

RE: COLLIERY DAM UPDATE

That Council direct staff to undertake design and installation of an Auxiliary Spillway (Labyrinth/Box Culvert, Open Channel alternative) for the Lower Colliery Dam and prepare a conceptual plan for the Middle Colliery Dam that complies with the Dam Safety regulations.

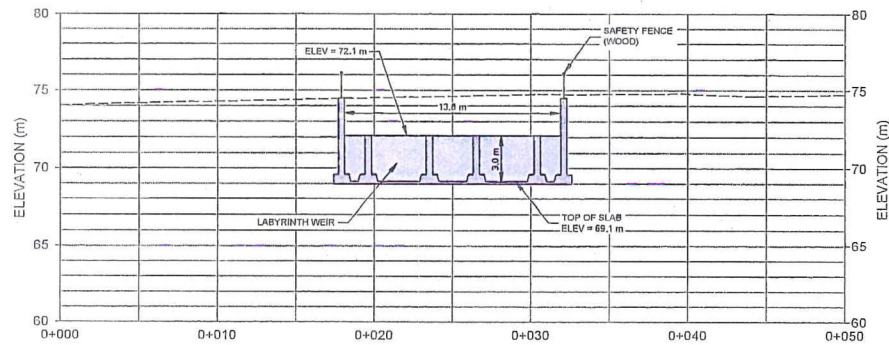
FIGURE 9b

SECTION A-A'
SCALE 1:300

SECTION B-B'
SCALE 1:300

SECTION C-C'
SCALE 1:300

- Figure 9b: Auxiliary Spillway to Harewood Creek Conceptual Sections Option 3 – Labyrinth/ Box Culvert/ Anchored Channel Option

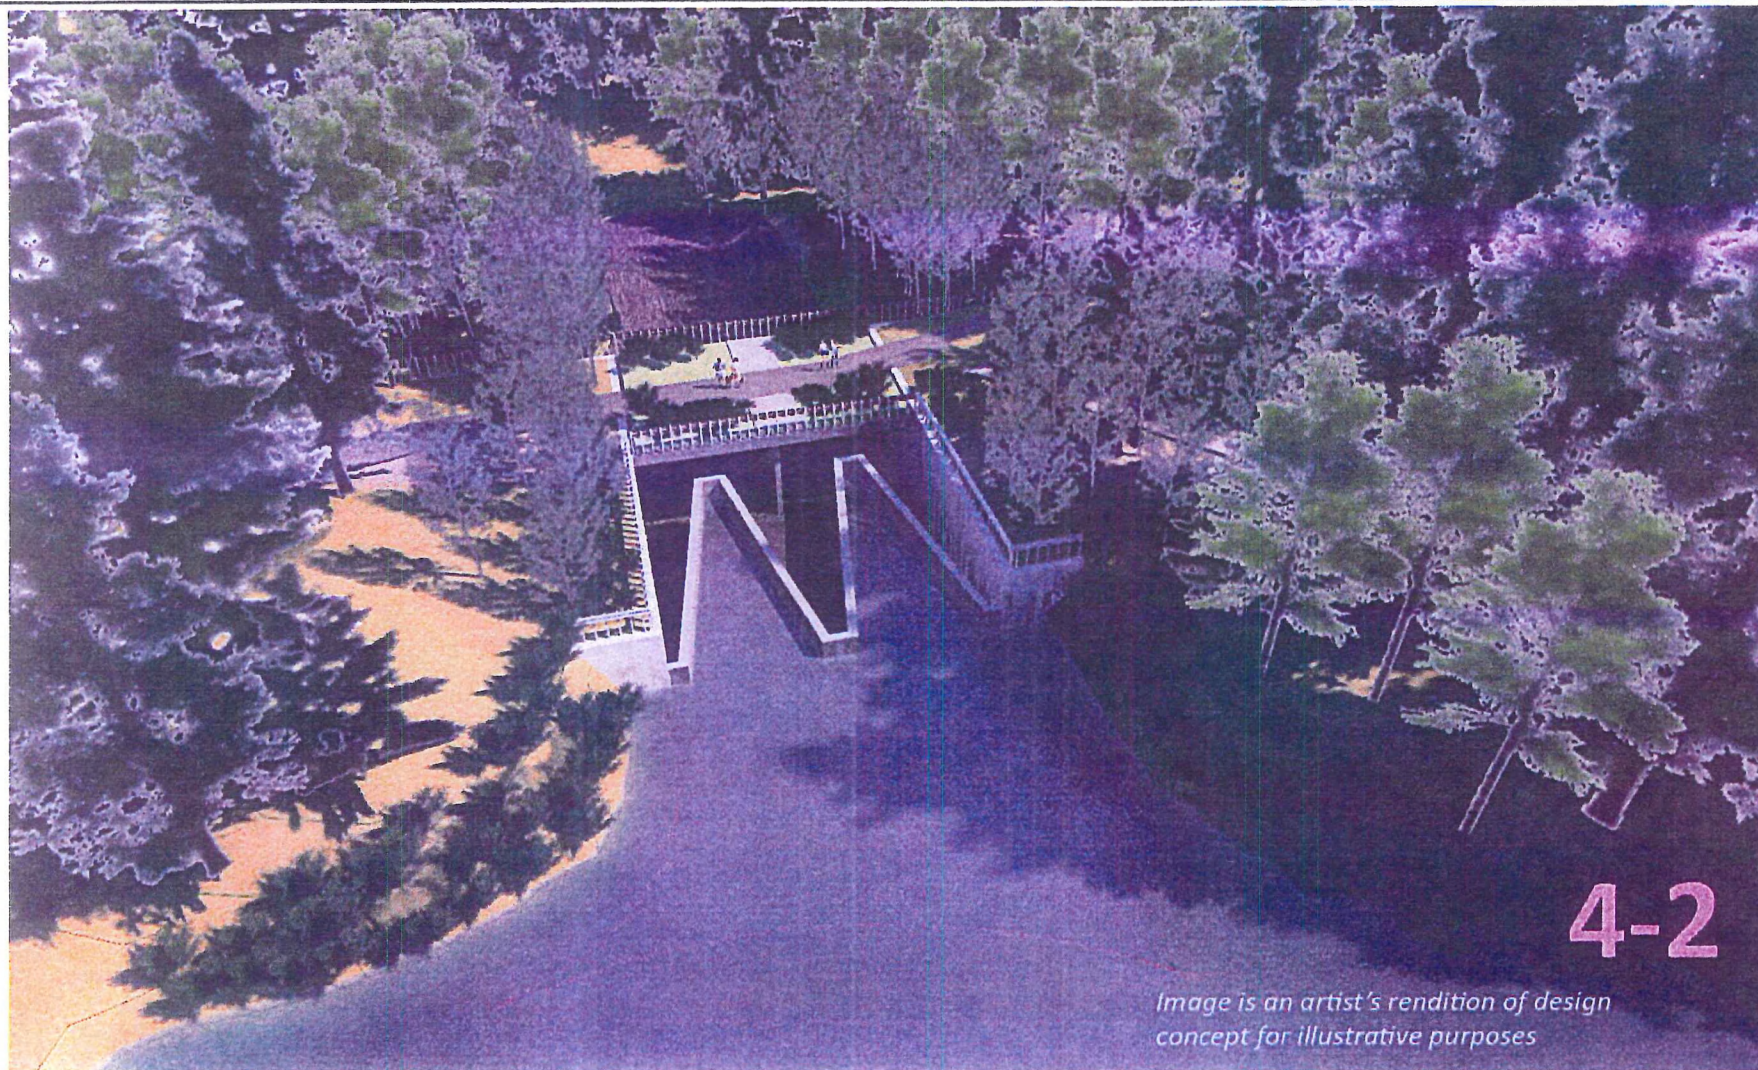
Figure D-7

Areal view from the north

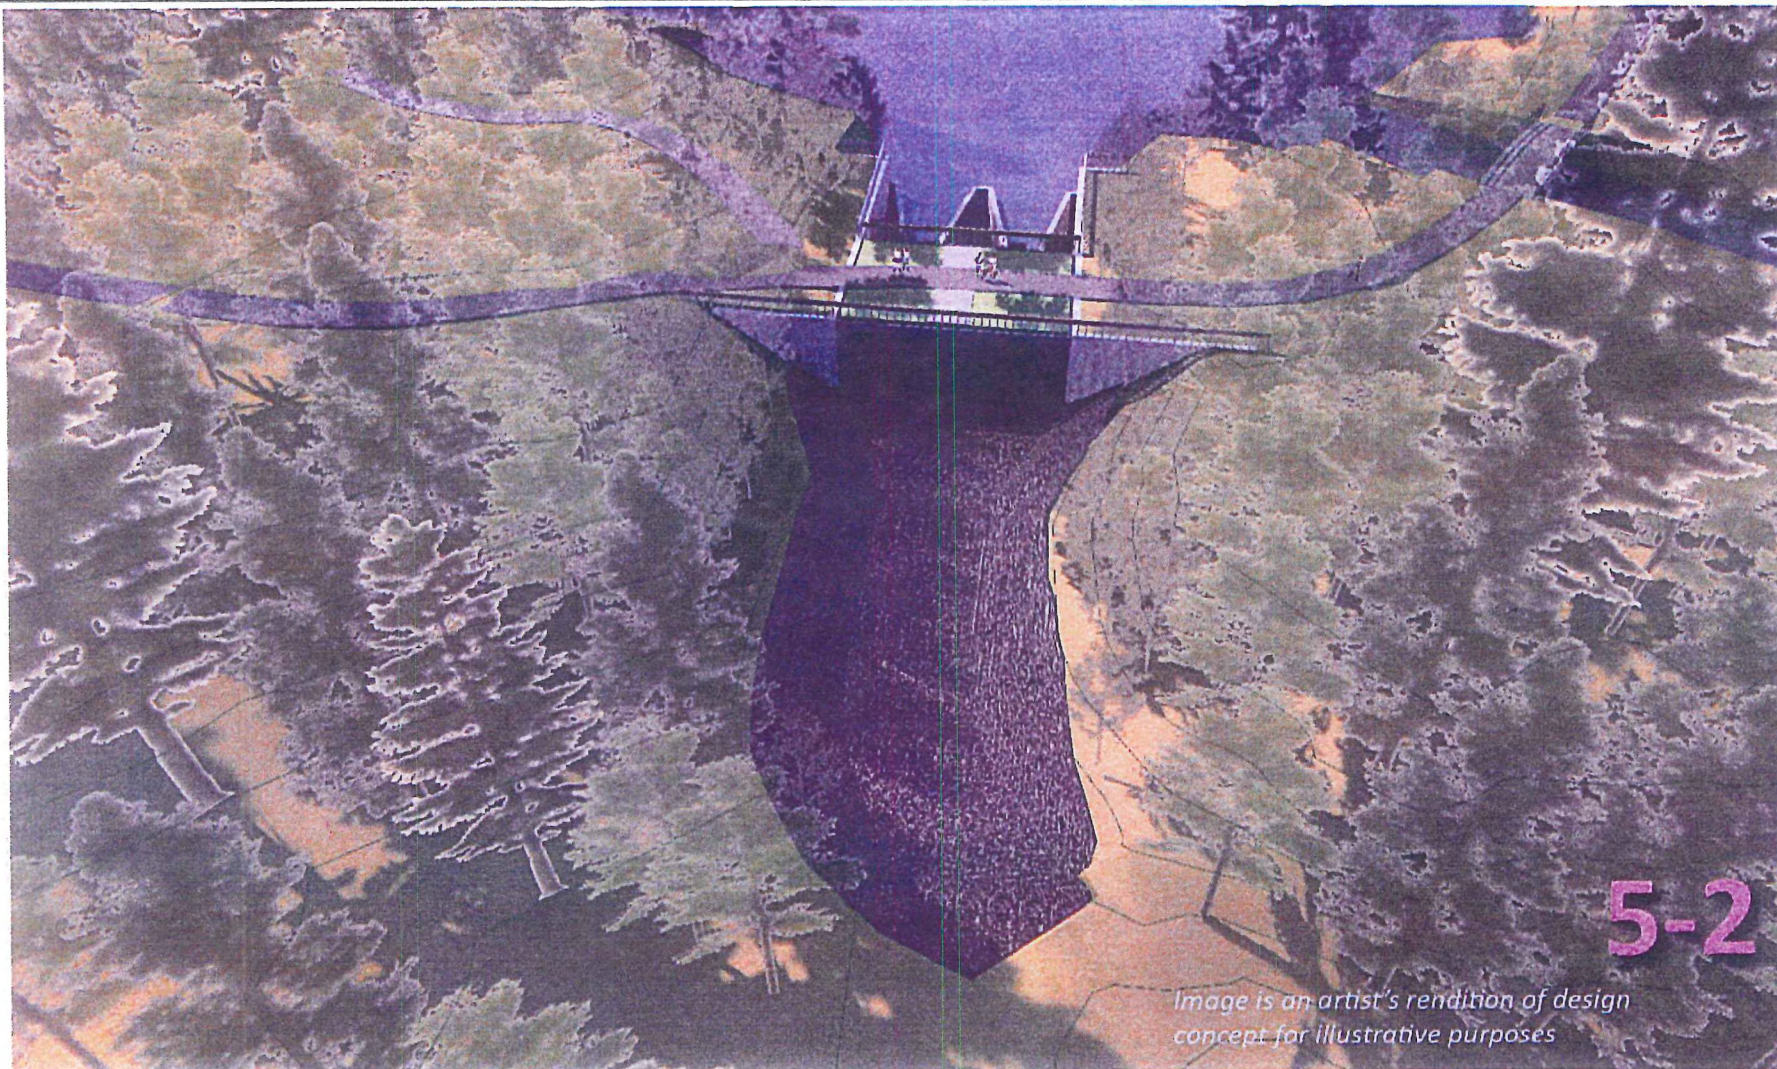
PROJECT		Colliery Dams Nanaimo, BC			
TITLE		Auxiliary Spillway to Harewood Creek Labyrinth / Box Culvert Open Channel Option 2			
PROJECT No.		1314470516		PHASE No. 2500	
DESIGN	DC	24 June 15	SCALE:	NTS	REV.
CADD	---		Figure D-8		
CHECK	JG	25 June 15			
REVIEW

Image is an artist's rendition of design concept for illustrative purposes

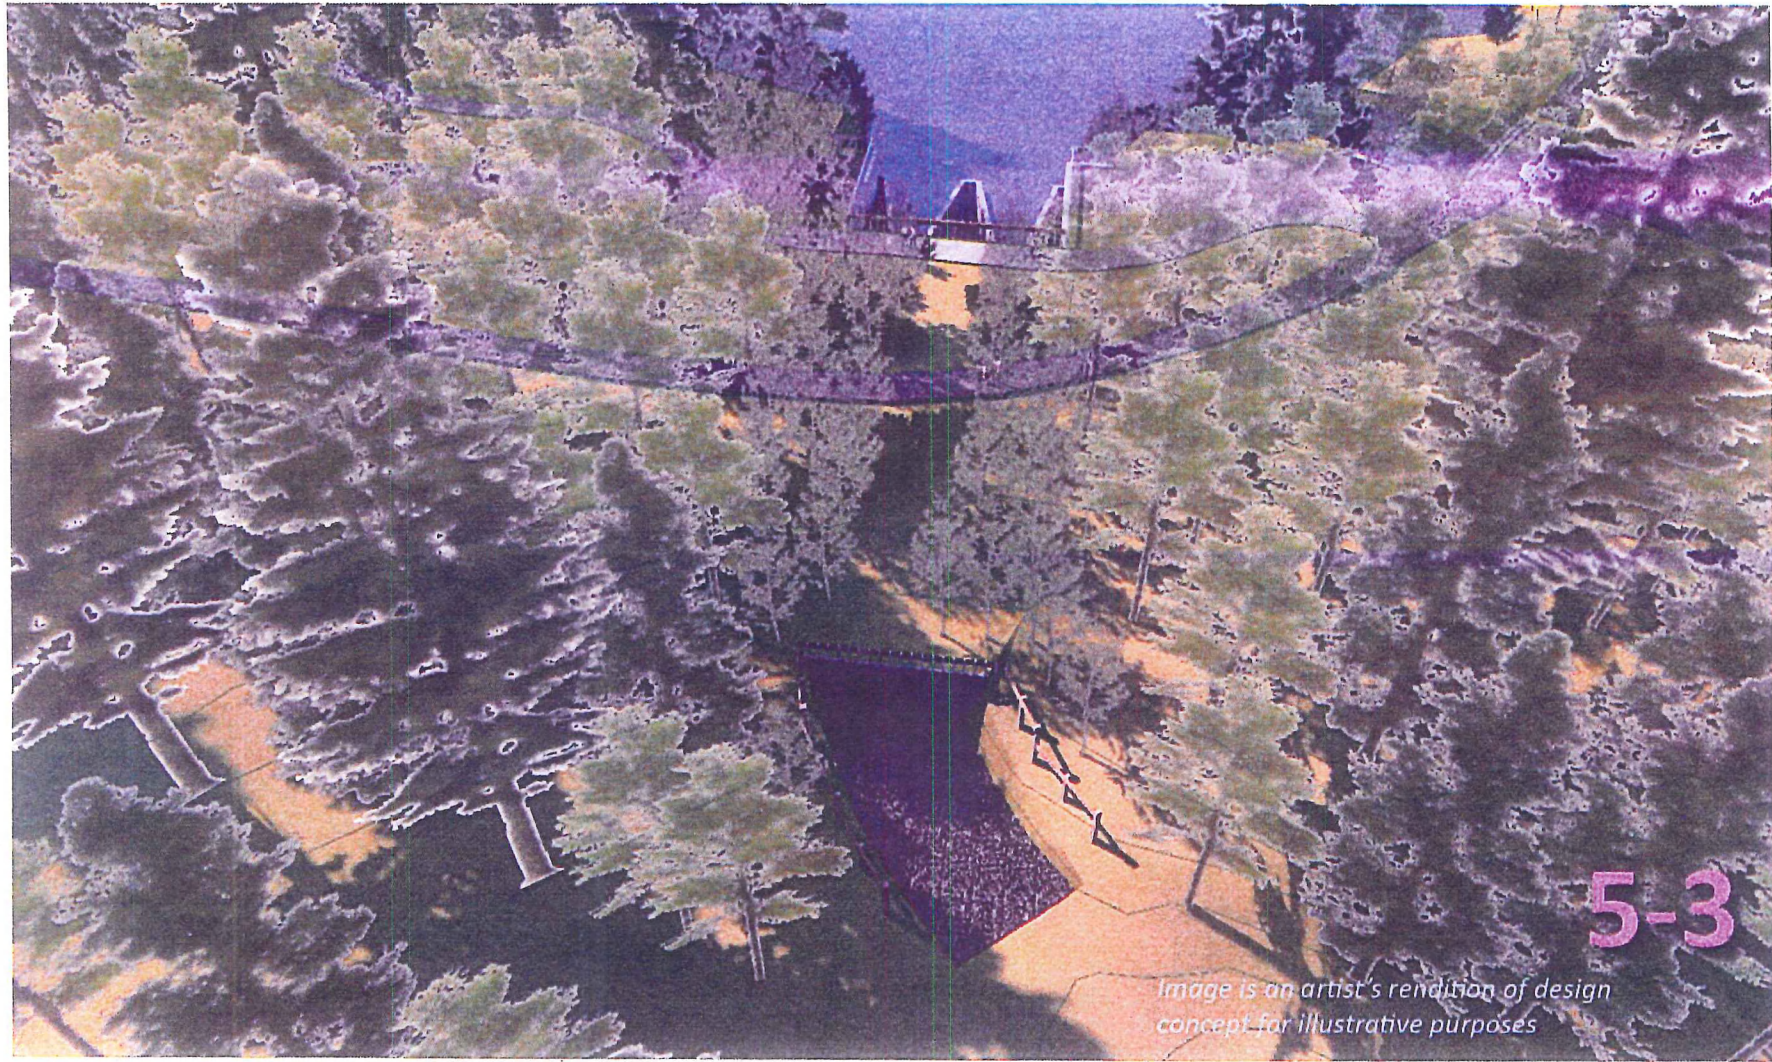
Figure D-10

Areal view from the south
