GUIDELINES FOR GEOTECHNICAL ASSESSMENTS ABOVE ABANDONED MINE WORKINGS

DRAFT

May 2024

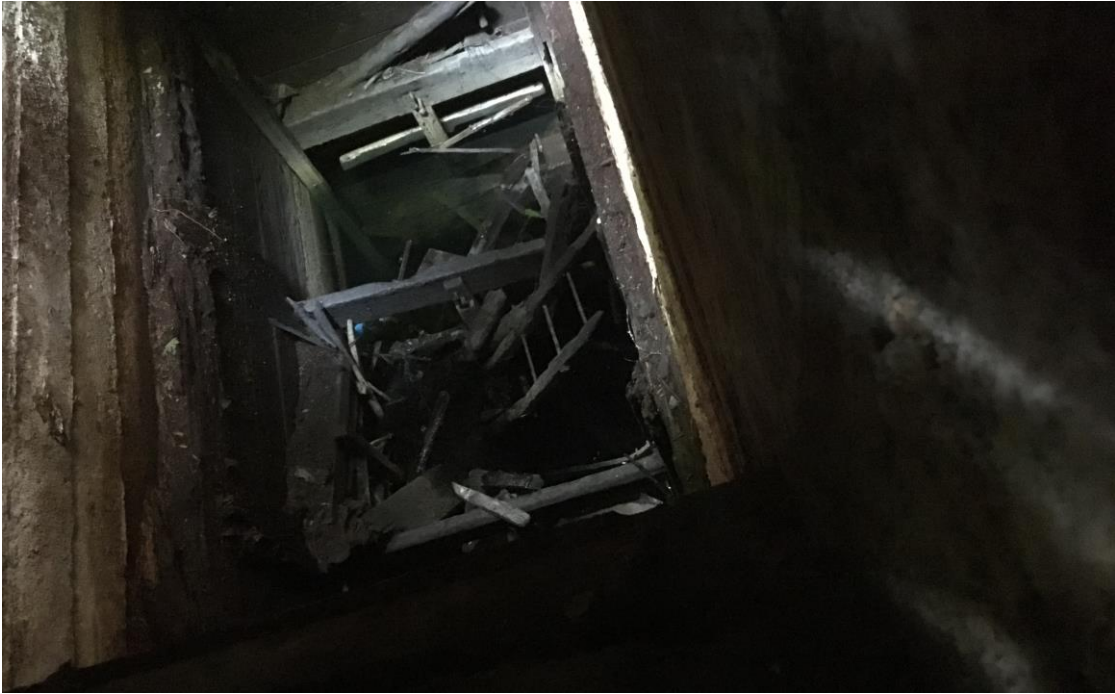
<p>Photo 1:</p> <p>Partially open mine shaft on Newcastle Island approximately 200 m deep</p>

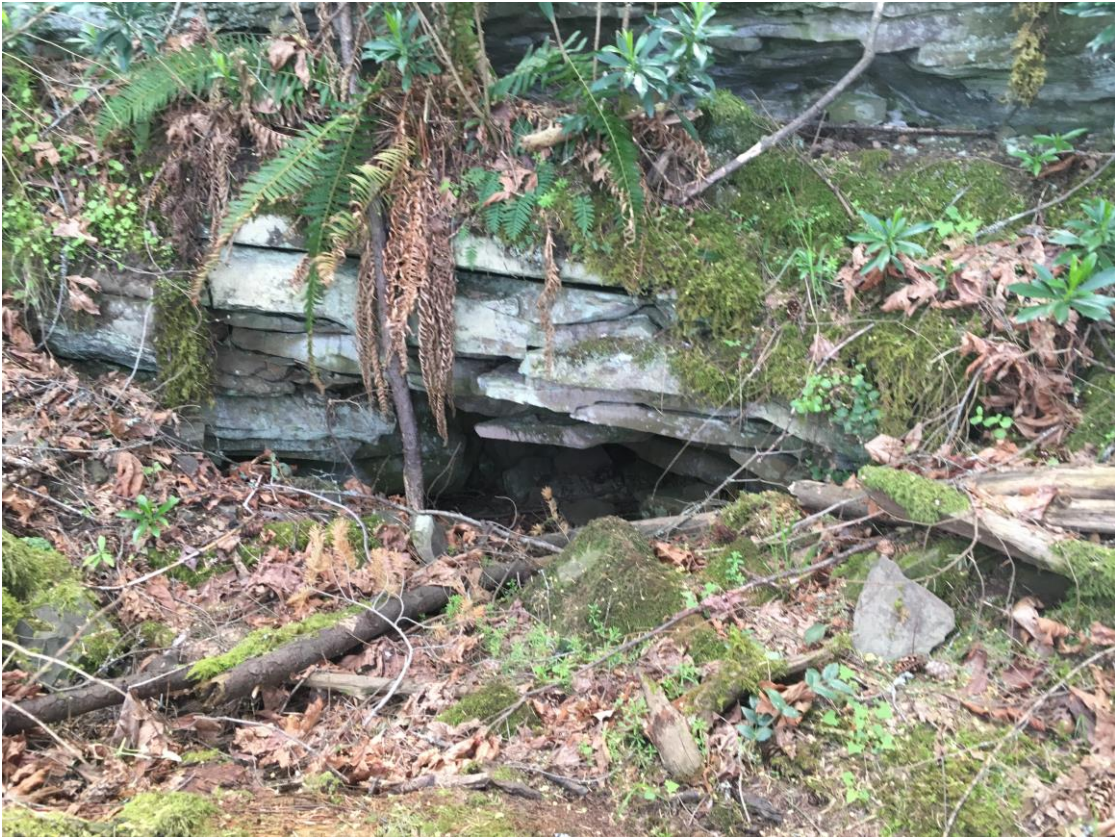
<p>Photo 2:</p> <p>Partially collapsed and backfilled slope entrance to the shallow abandoned workings of the Fitzwilliam Mine</p>

- The potential for sudden ground collapse associated with all openings to mine workings and prospecting works including shafts, slopes, and adits. The preliminary assessment identified some 55 vertical shafts and some 35 inclined or level slopes and adits within the City limits. There may be significantly more unrecorded openings that were created for ventilation in shallow mines and related to the poorly recorded secondary mining extraction activities that followed the abandonment of the main workings. The attached Photo 1 shows an example of an open shaft on Protection Island while Photo 2 shows a partially collapsed unsupported slope leading to the shallow abandoned workings of the Fitzwilliam Mine; and

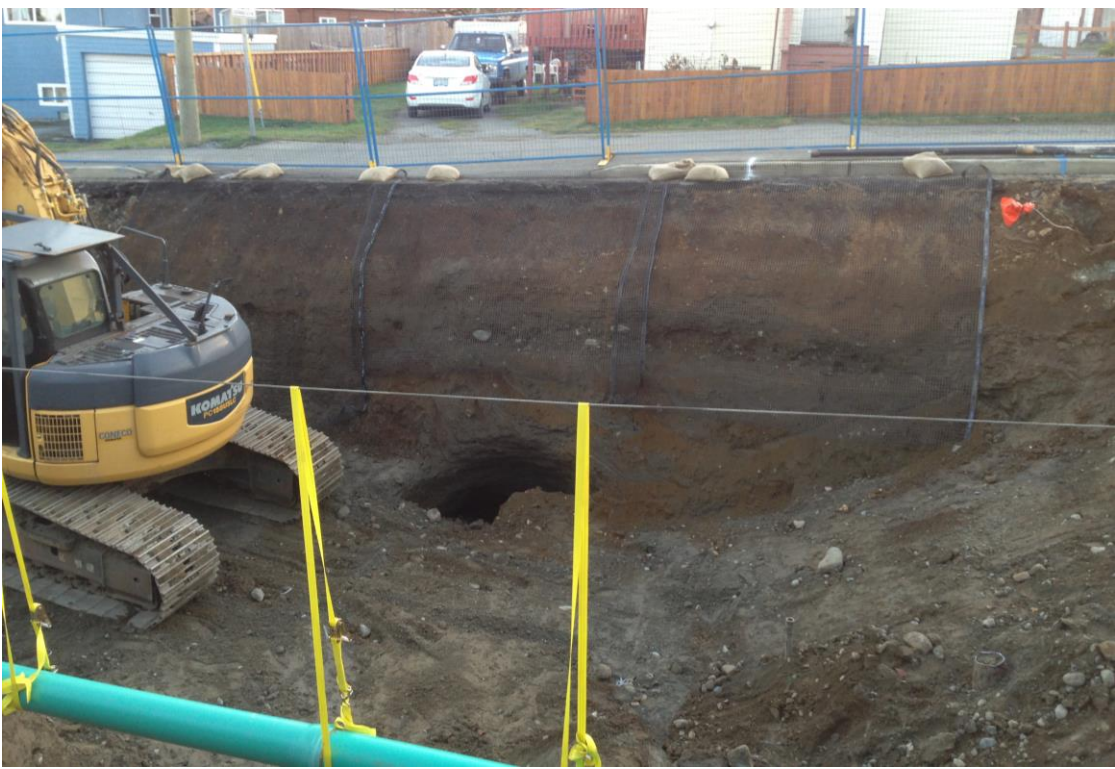
<p>Photo 4:</p> <p>Mine roof collapse and migration of soils above the Douglas Mine on Fifth Street, Nanaimo encountered during shallow utility replacement works.</p>

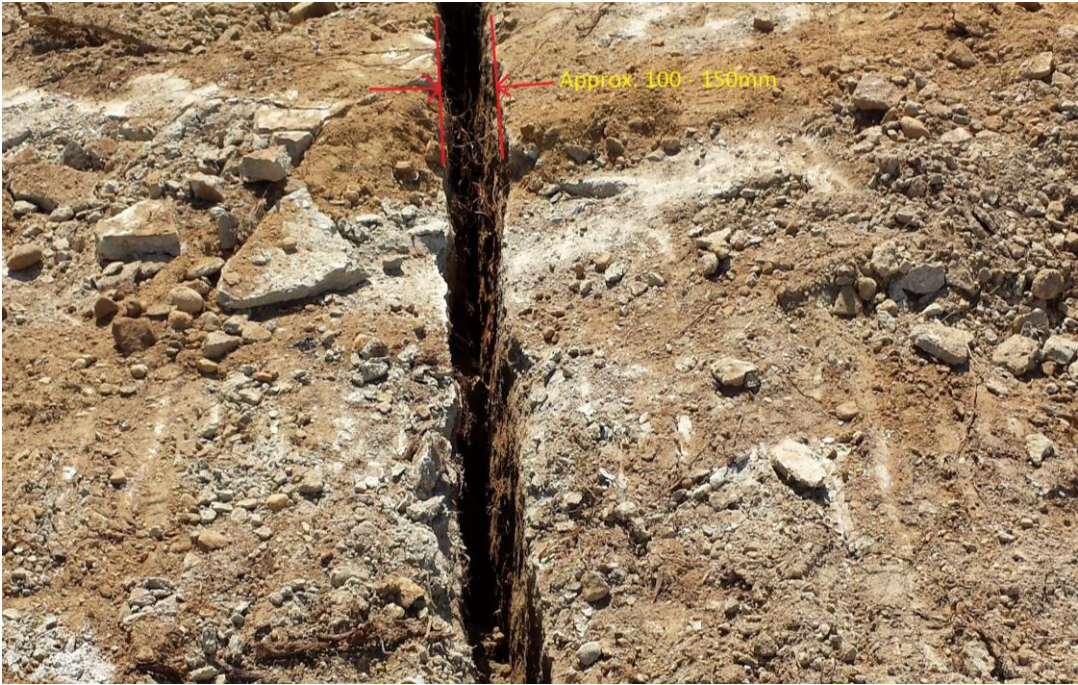
<p>Photo 5:</p> <p>Open fractures above shallow workings of the Wellington Mine in the Gilfillan Road area.</p>

- The potential for roof rock failure leading to a crown or sink hole at the ground surface in areas above abandoned room and pillar mine workings with an inferred roof cover of rock of less than 10 times the seam thickness. Specific areas of high risk related to this hazard include portions of the west side of the Douglas Mine; the shallow workings of the Fitzwilliam Mine at the north end of Newcastle Island; and the north-westerly portion of the Wellington Mines, where there is a complex history of extraction from two shallow coal seams along with a poorly documented record of secondary pillar robbing that extended into the 1960's. Photo 3 shows shallow partially collapsed open workings under Victoria Road while Photo 4 shows a portion of crown hole that was encountered at the western edge of the Douglas Mine during a shallow utility replacement program. Photo 5 indicates the nature of open fracturing above the shallow abandoned Wellington Mines in the Gilfillan Road area.
